2D Resistivity Imaging Investigation of Long Point, Katy-Hockley, Tomball and Pearland Faults, Houston, Texas

Mustafa Saribudak

Environmental Geophysics Associates, Austin, TX, USA
ega@pdq.net

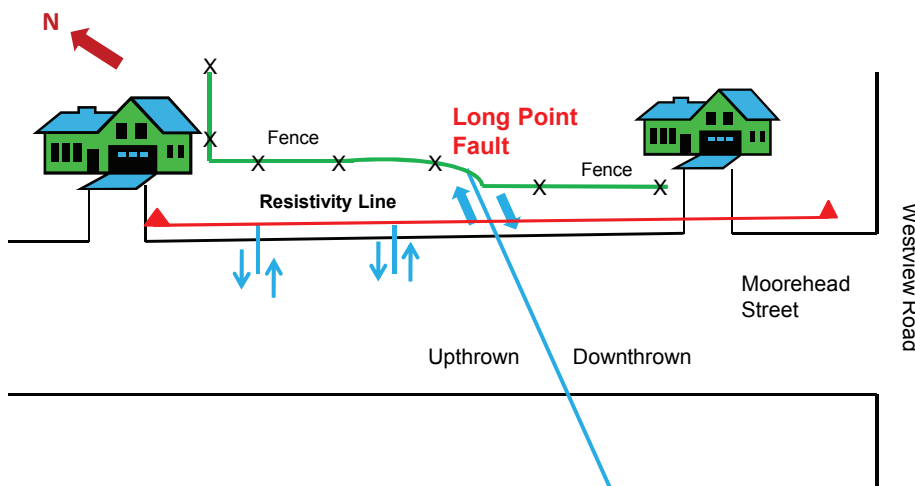
Figure 2.

Schematic map of Long Point fault at Moorehead Street. Note the presence of two small faults in the upthrown side of the fault, and the deformation on the the fence line. Resistivity line is shown with a red line.

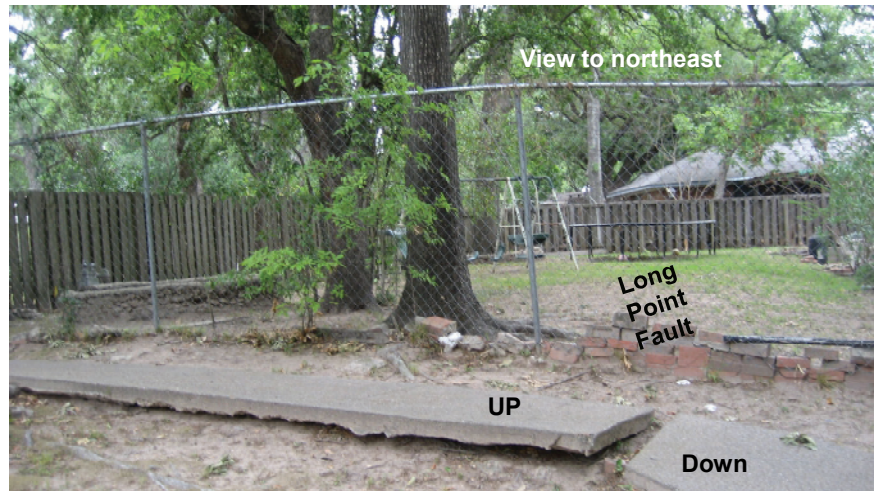
Figure 3.

Long Point fault scarp across Moorehead Street. Note the fault related deformation on the concrete path for pedestrians.

2). At the Moorehead Street location a discrete fault scarp deforms the road, curbs and sidewalks (Figure 3). Figure 4a shows the approximate location of the Beltway 8 and I-10 study area, where the fault clearly deforms the fence, respectively (Figure 4b and Figure 5).

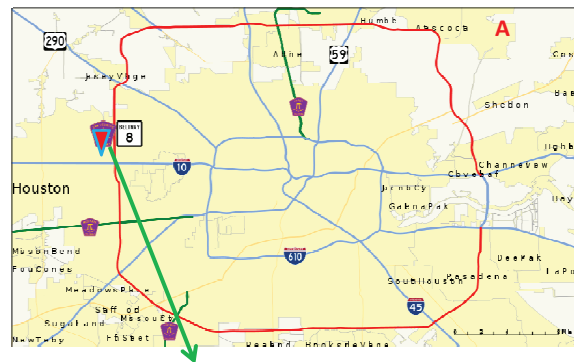
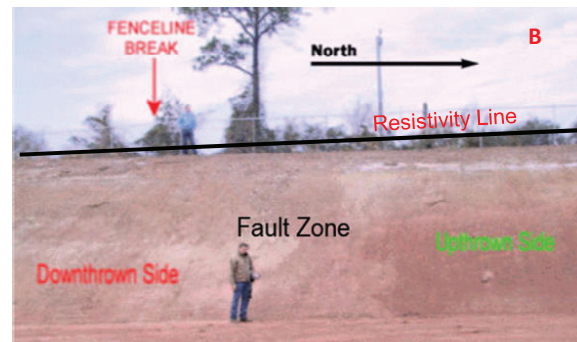
Figure 4.

a) Location of Beltway 8 and I-10 resistivity profile; b) a photo taking in 2006 shows the west wall of the excavated pit for the development of the water detention pond (picture is revised from Britt, P. 2006). Note the location of the resistivity line.

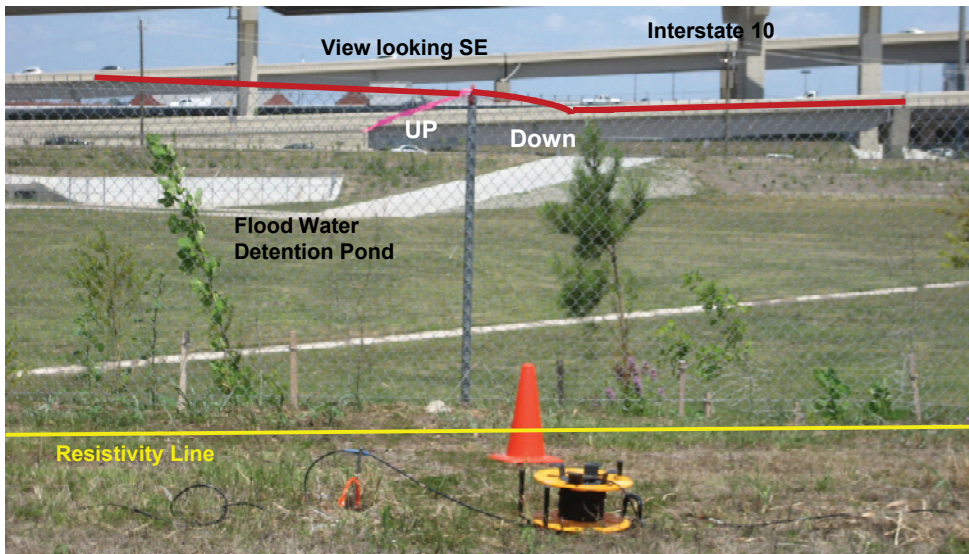
Figure 5. A picture taken in 2011 shows the resistivity line with respect to the west wall of the detention pond, which is fenced, and the fence break-line indicates the fault location.

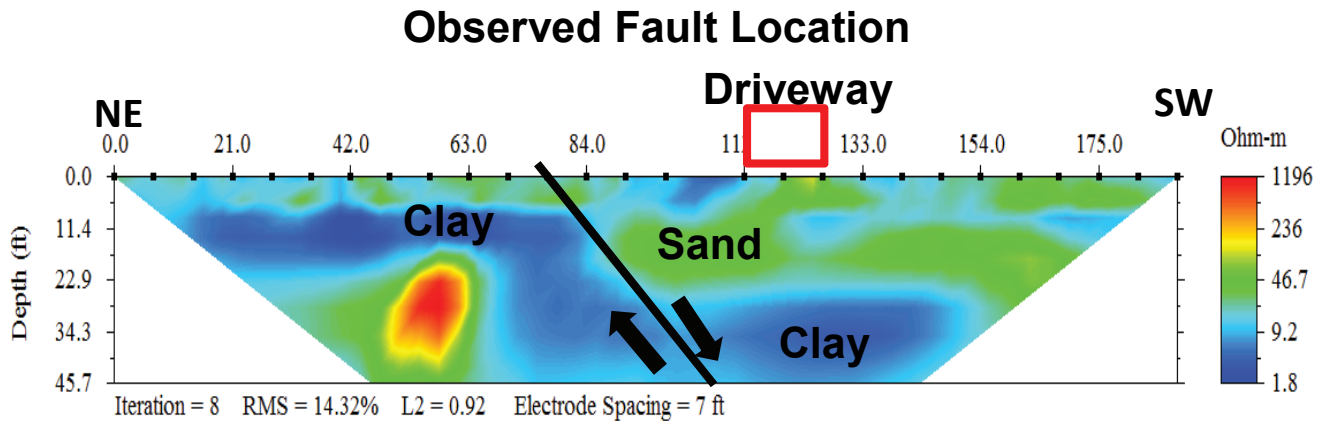
The resistivity data collected along the Moorehead Street is shown in Figure 7. A fence-line break and the driveway of a nearby house are given for references. The fault juxtaposes low resistivity soil layers (clay as

displayed by the blue) against moderately resistive units (sand as displayed by green color). The Long Point fault location observed at the site is superimposed on the resistivity imaging data, which shows south-dipping clay layers on the south part of the fault trace. The northwest part of this anomaly is limited by a high resistivity layer shown by the red color.

Figure 7. Resistivity imaging data taken along Moorehead Street across the Long Point fault.

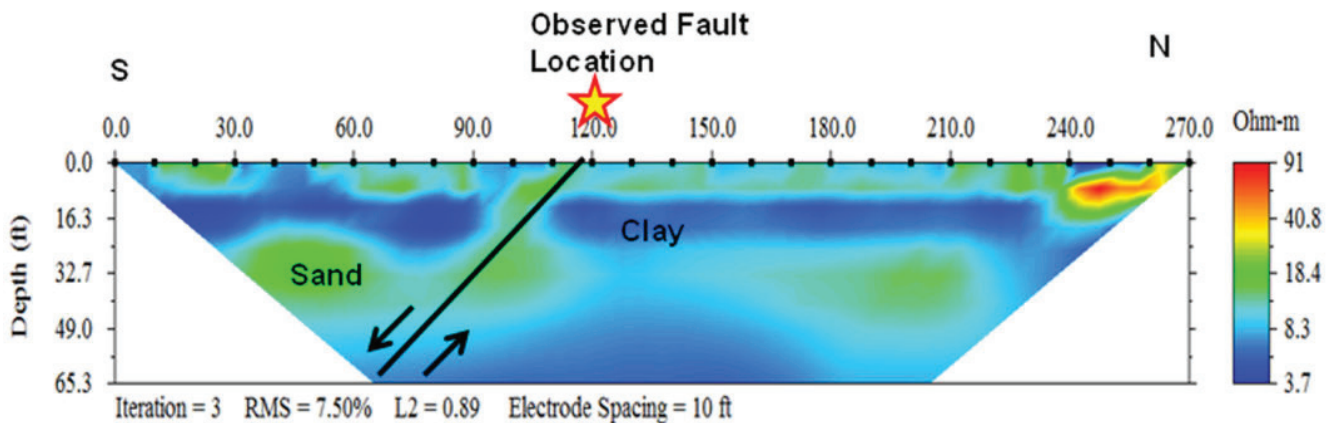
Resistivity data collected over the fault show south-dipping clay layers in the south part of the Long Point fault (Figure 8), which juxtaposes low resistivity soil (clay as displayed by the blue color) against moderately resistive units (sand as displayed by the green color).

Figure 8. Resistivity imaging across Long Point fault. Note the south-dipping clay layers in the downthrown side.

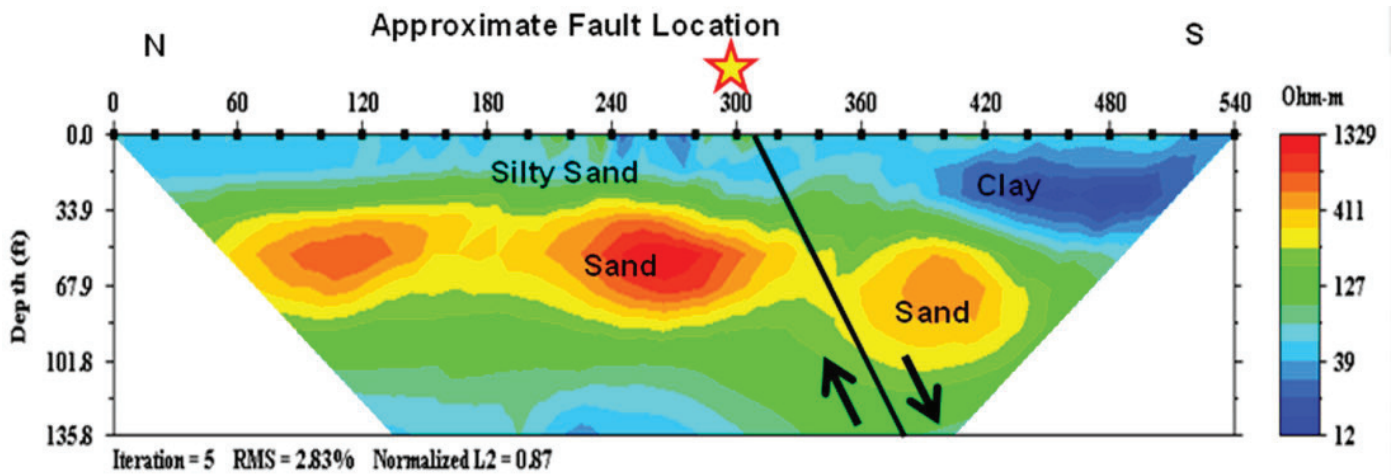
The E-W striking and south-dipping Katy-Hockley fault crosses Katy-Hockley Road 2235 feet to the north of the intersection of Jack and Katy-Hockley Roads. There was no deformation observed on the road because the road was built newly prior to the resistivity survey. The resistivity data collected across the fault (Figure 9) indicate a thickening of the clay and sand units on the downthrown side of this growth fault.

Figure 9. Resistivity imaging data taken across the Katy-Hockley fault. Note the south-dipping sand layers and thickening clay layers in the downthrown side.

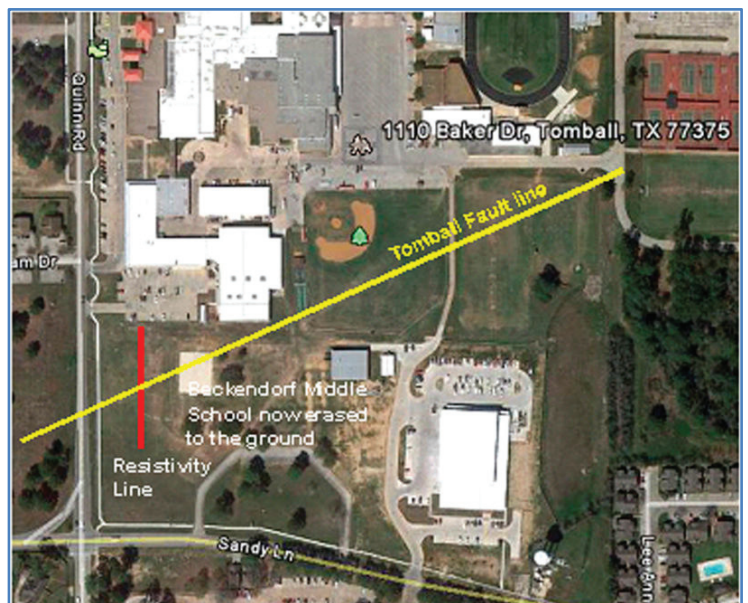
The Tomball fault is one of the major regional faults of the Houston area, and is located in Tomball City. The fault strikes in the east-west and crosses SH 249. Further east, it runs through Beckendorf Middle School, which is located between Sandy Lane and Quinn Road (Figure 10). The fault deformed and damaged the west entrance of the school extensively. Because of the destruction of the property, the school was closed permanently in 2009.

Figure 10. Beckendorf Middle School site map showing the Tomball fault line and location of the resistivity profile.

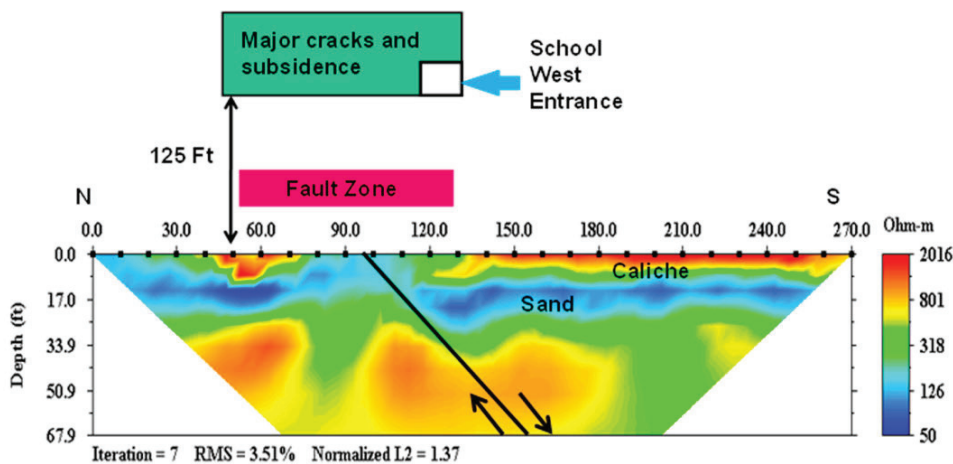
A line of resistivity data (Figure 11) was collected across the fault in the western part of the school area. The resistivity data is shown in Figure 11, which also shows the sketches of the school and deformation zone schematically. Available borehole data from the site indicates caliche. The resistivity data indicates a significant deformation

Figure 11. Resistivity imaging data taken across the Tomball fault at the western side of the Beckendorf Middle School. Note the significant deformation within the fault zone defined by the resistivity data, and thickening sand layers in the downthrown side of the fault.

zone between stations 50 and 130 feet, in which sand layers are displaced upwards and downwards. Away from the fault zone, the sand layers are horizontal. We observed major cracks on the wall of the school corresponding to the resistivity anomalies.

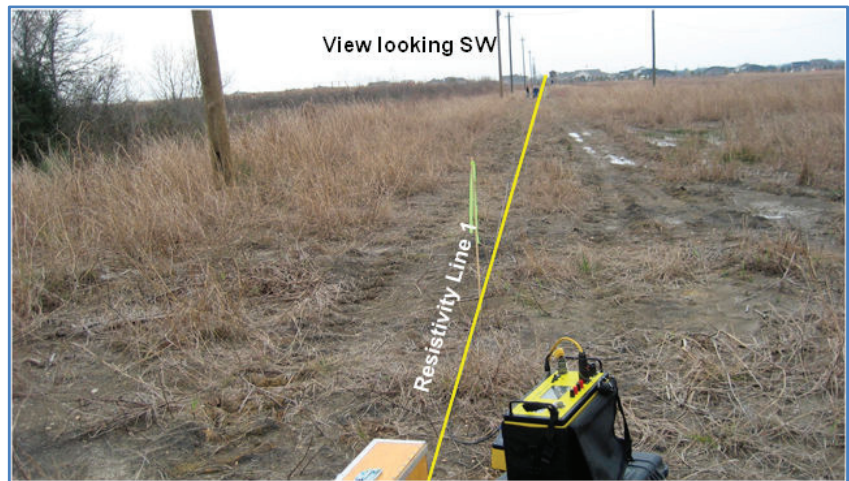
Figure 12. A picture, looking SW, showing the location of resistivity line 1 across Pearland fault.

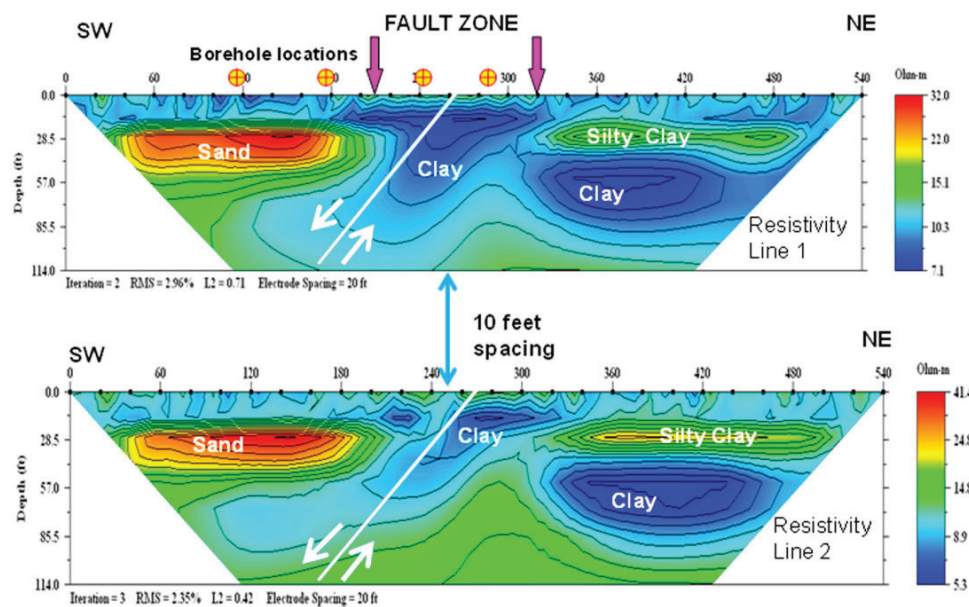
Results of both profiles are shown in Figure 13. Data from the 4 boreholes were used to project the surface location of the fault (at about 260 ft) along the profiles; the fault dips about 70° to the SW. Both resistivity profiles indicate a low resistivity area between stations at 220 and 320 feet. The resistivity for this anomaly varies between 5 and 10 Ω-m, which is indicative of clay. This low resistivity zone was interpreted to be a fault zone anomaly prior to any knowledge on the exact location of the fault. Note the approximate correlation of the fault location based on the borehole data (station 260 feet) and the resistivity data (between stations 220 and 320 feet).

Two resistivity imaging data sets taken across the Pearland fault. The fault location was not known prior to the resistivity surveys. Location of the fault is based on the four borehole data, and is projected onto the resistivity data.
