# Geophysical mapping of the Hockley growth fault in northwest Houston, USA, and recent surface observations

MUSTAFA SARIBUDAK, *Environmental Geophysics Associates*

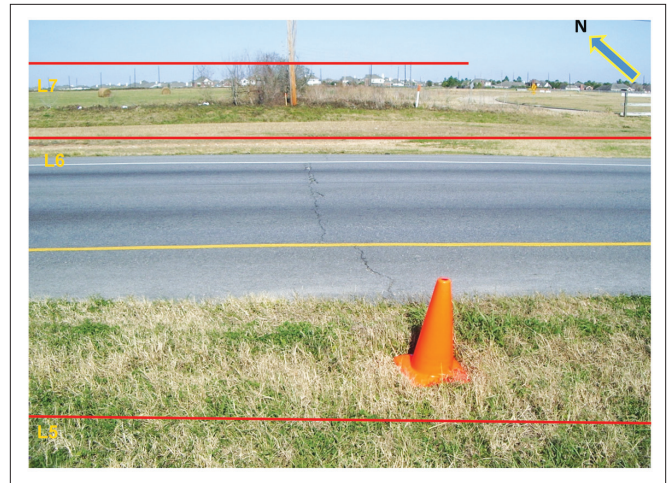
**Figure 4.** A picture showing a significant crack on the westbound lane of Highway 290 prior to the construction of a shopping mall. The picture was taken facing north. Approximate locations of resistivity profiles L5, L6, and L7 are shown.

During the surveys in 2004, I sketched the locations of the cracks and patched pavement locations on both sides of the highway and mapped a discrete fault scarp on the south side of the highway (Figure 3). Another fault scarp was also mapped along one of the resistivity profiles, in an open field between the highway and Fairfield Village (Figure 3). In addition, a major crack is observed crossing the highway on the north side (Figure 3 and 4). Resistivity profiles L4, L5, and L6 crossed over this significant crack.

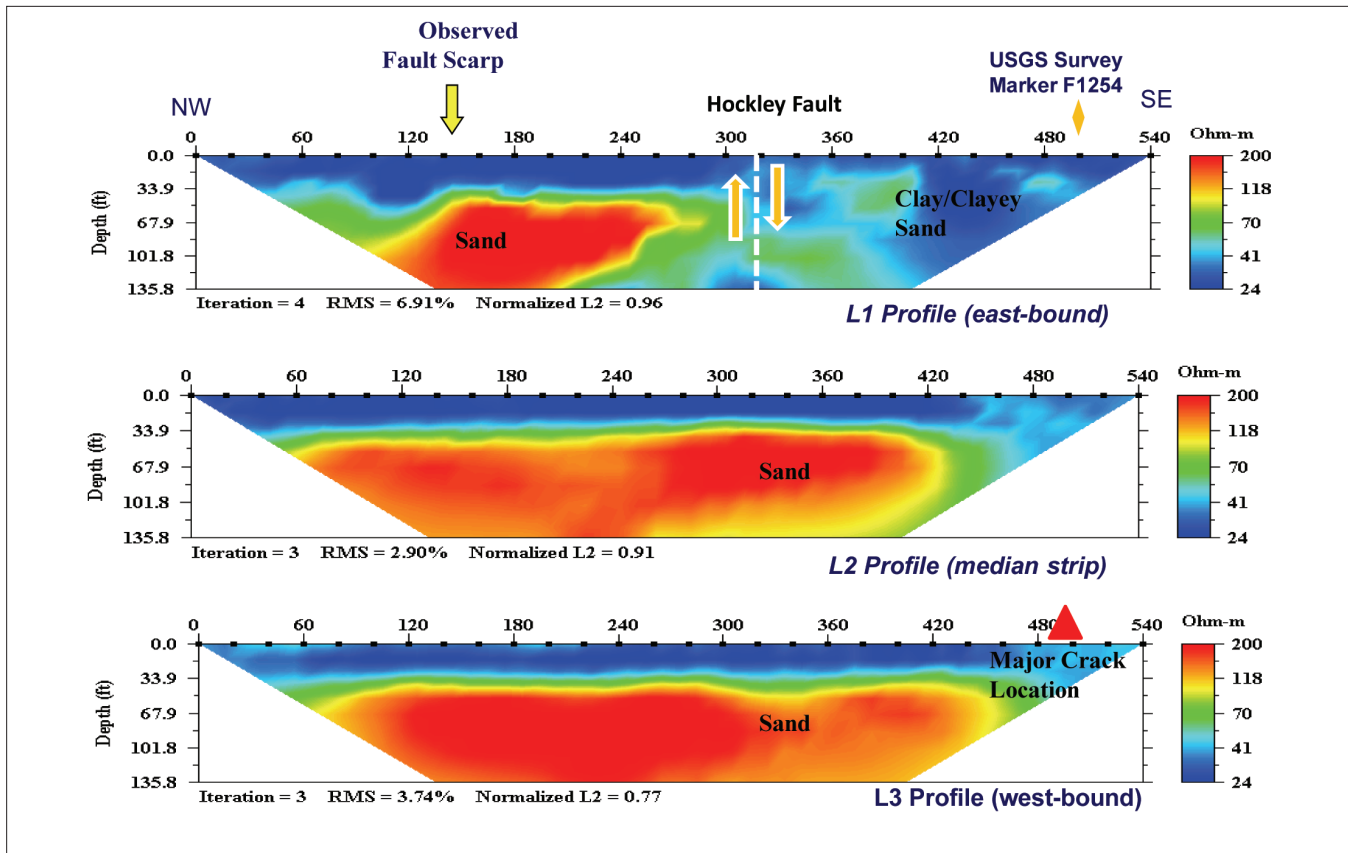
Figure 5. Resistivity imaging data along profiles L1, L2, and L3 (see Figure 3 for locations).

The resistivity profiles in Figures 5–7 indicate sandy clay and sand units. Spacing of resistivity profiles L1, L2, and L3 (Figure 5) is from 75 to 100 ft. Profile L1 does not indicate any fault offset visible in the soil layers over the fault scarp, which where present was several inches in height. Instead, a fault-like anomaly is observed at approximately 300 ft to the southeast. Resistivity profiles L2 and L3 do not indicate any fault offset along their entire lengths. However, there is an apparent resistivity contrast toward the end of the profiles between the sand and clay layers, although confidence in the

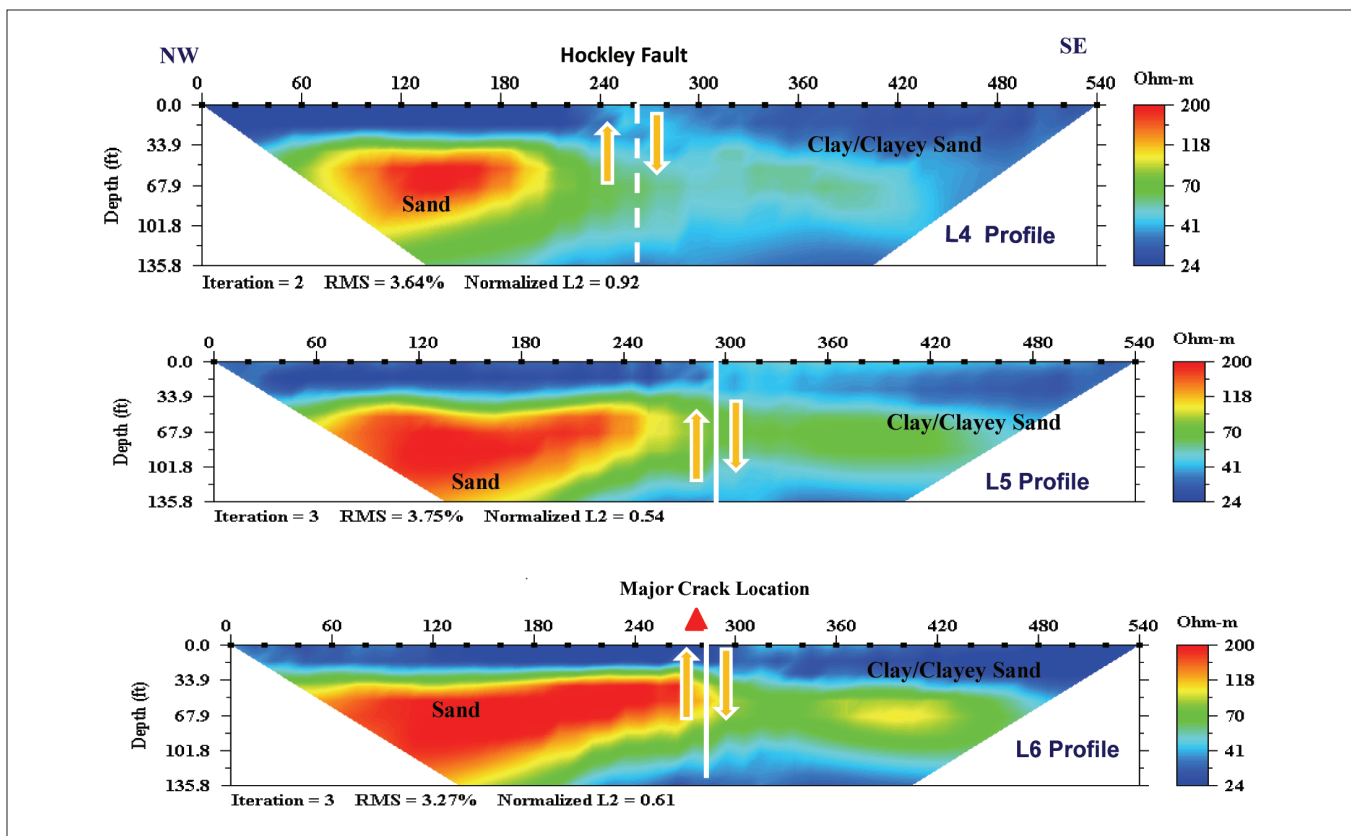
Figure 6. Resistivity imaging data along profiles L4, L5, and L6 (see Figure 3 for locations).

In order to map the resistivity contrast, three more resistivity profiles (L4, L5, and L6) were surveyed (Figure 6). A fault-like anomaly is present from 240 to 280 ft on all three data sets.

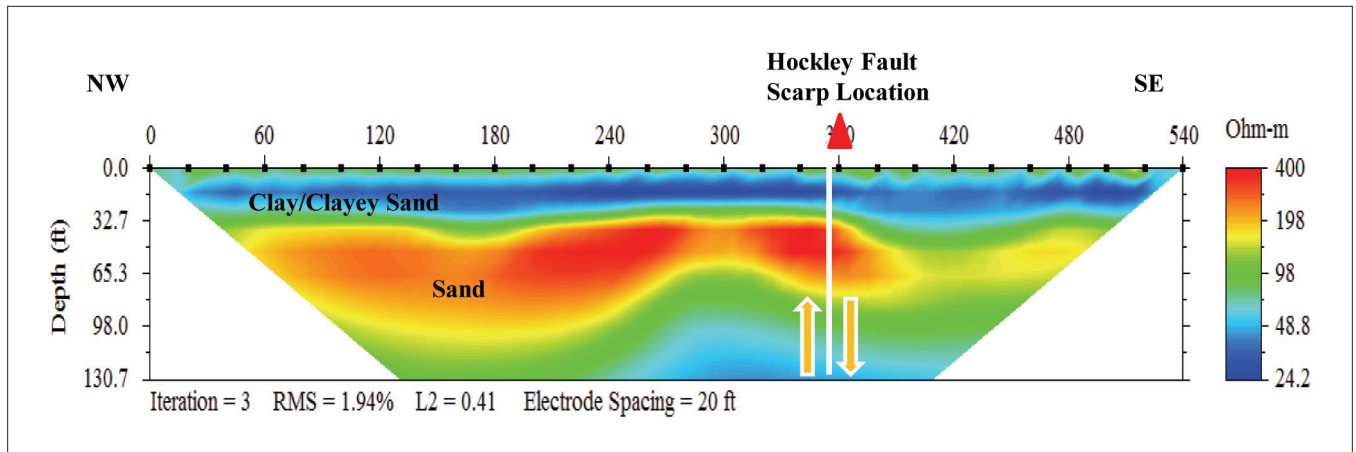
**Figure 7.** Resistivity imaging data along profile 7. Note the correlation of the resistivity anomaly and observed fault scarp in the field. Note also the increased thickness of the clay/clayey sand (blue) in the downthrown side of the fault (see Figures 3 and 4 for location).

Figure 7 shows resistivity profile L7, which was taken in an open field between the westbound lane of Highway 290 and Fairfield Village. This area was covered with vegetations during acquisition. For reference purposes, the SE end of the

profile was next to the asphalt pavement. A distinctive fault scarp (several inches in height) was observed at this location, and profile L7 displays the resistivity data over the fault. The fault scarp was located at a station 360 ft on the resistivity profile and a fault-like anomaly is observed in the data at that same station.

downthrown to the southeast. The observed surface location of the fault scarp correlates well with the interpretation of resistivity Line 7. The combination of clayey sand with 24 ohm-m resistivity (shown in blue), and sand layers with 70 ohm-m resistivity (shown in green) is indicative of a dipping and curved fault plane. No fault like anomaly (no offset between the soil layers) is evident in the resistivity data from L2 and L3. Resistivity profile L1 possesses an anomaly at the approximate location of the fault but does not display the characteristic layer offset interpreted on the other profiles. The reason for this may be the presence of more clayey soil where

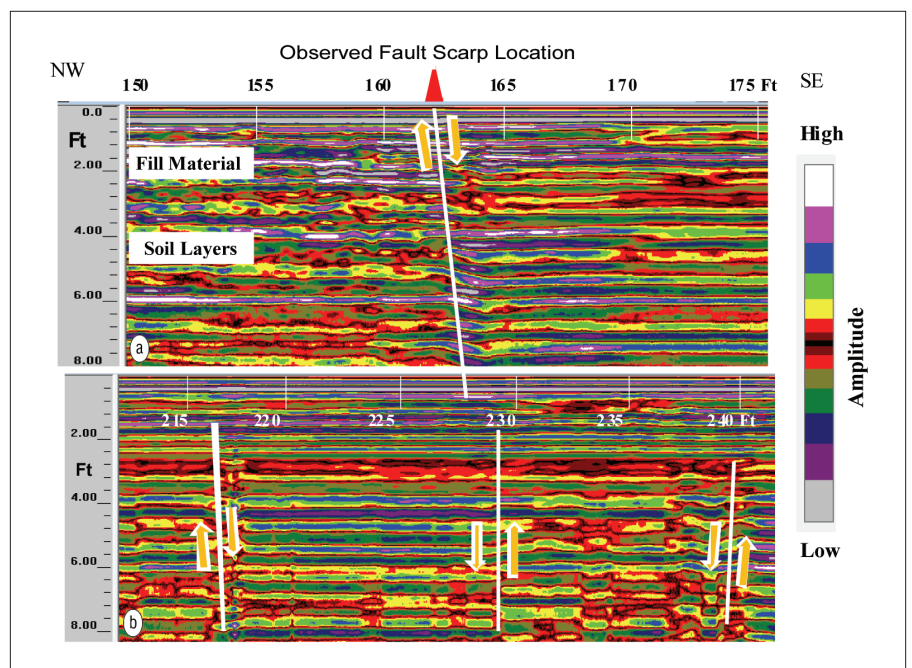
**Figure 8.** GPR data along line 1 between stations 150 and 175 ft (a) and stations 215 and 240 ft (b). Note the fault offset of GPR data over the scarp location. There are small-scale faults downthrown to the southeast as well as to northwest.

A vertical offset over the fault scarp can be observed at approximately 160 ft in Figure 7a. This offset includes the fill materials and the underlying soil layers. Figure 7b shows several small-scale faults between stations 215 and 240 ft. Figures 8a and 8b show small faults between stations 250 and 415 ft. Small faults between stations 430 and 470 ft are evident on Figure 10. Two micrograben-like structures, approximately 14 ft in length, are defined by the small-scale faulting.

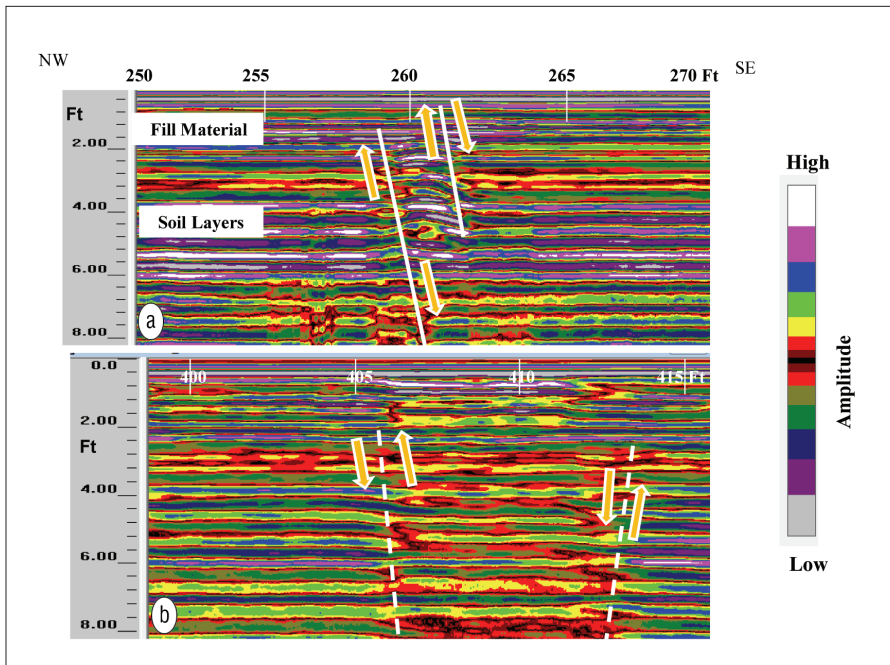
**Figure 9.** GPR data along line 1 between stations 150 and 175 ft (a) and stations 215 and 240 ft (b). There are small-scale faults downthrown to the southeast as well as to the northwest.

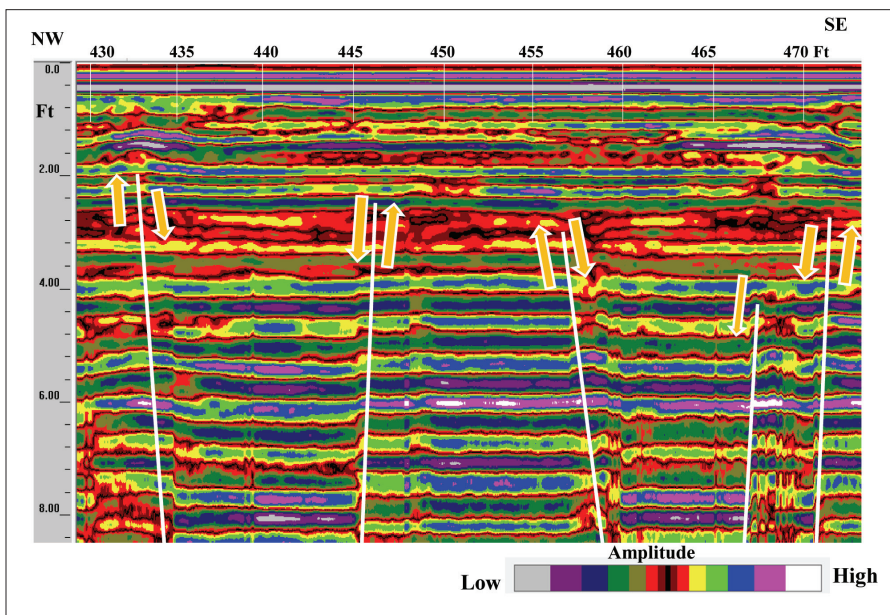
**Figure 10.** GPR data along line 1 between stations 430 and 470 ft. There are small-scale faults downthrown to the southeast as well as to the northwest. Note the graben-like structure between stations 430 and 445 ft and 455 and 470 ft.

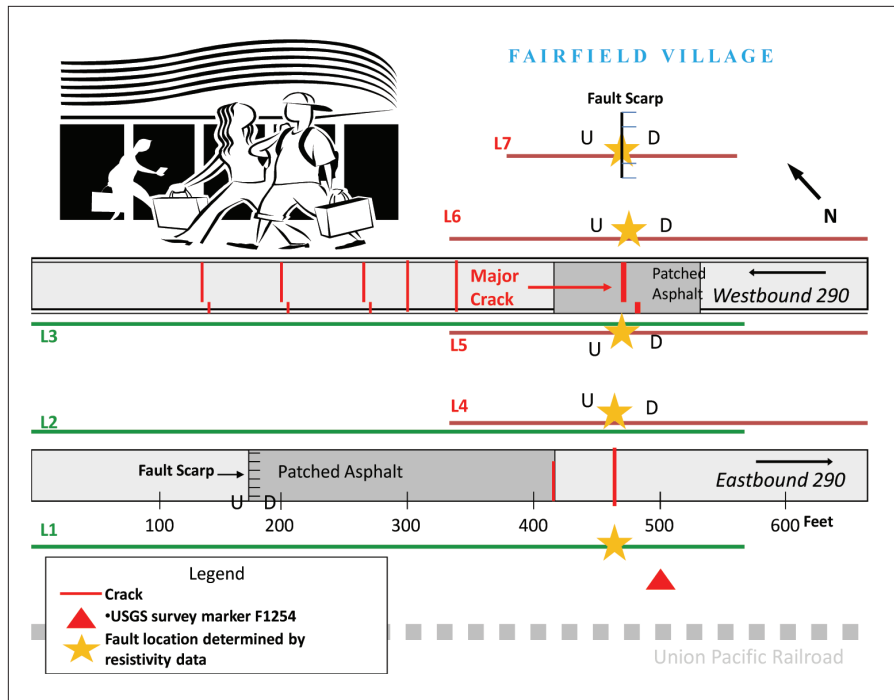
Figure 11. Approximate locations of Hockley fault determined by the geophysical data. A sketch of the shopping mall is shown in the NW section of the study area.

The resistivity and GPR data indicate a wide zone of deformation across the Hockley fault. Geophysical data presented here combined with the field observations indicate a deformation zone of approximately 400 ft that includes the east- and westbound lanes of Highway 290 (now access roads to the shopping mall). The principal fault plane and its associated shallow zone of deformation are in the vicinity of a newly built shopping mall. The zone of fault-induced deformation extends under the eastern part of the parking lot and the major entrance road to the mall (Figure 12).

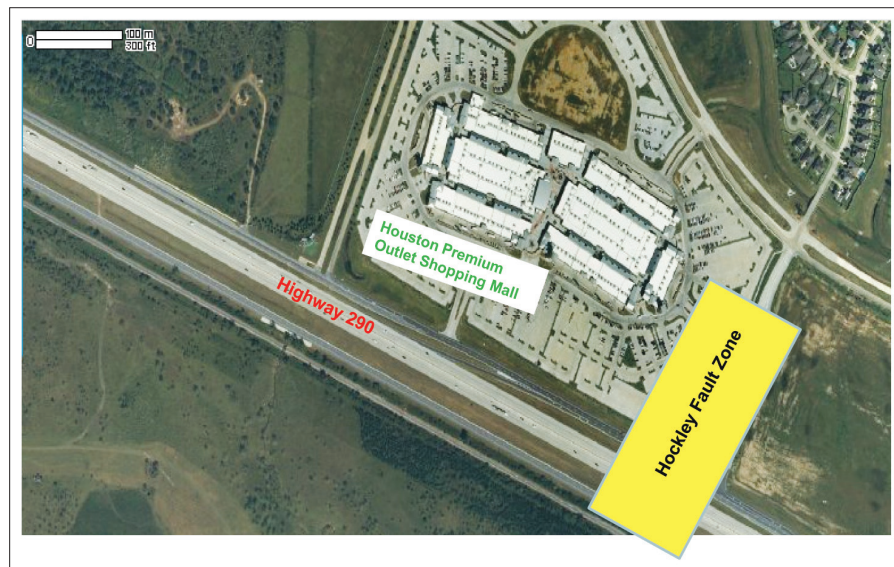
Figure 12. Map showing approximate extension of the Hockley fault zone in the vicinity of Houston Premium Outlet Shopping Mall.

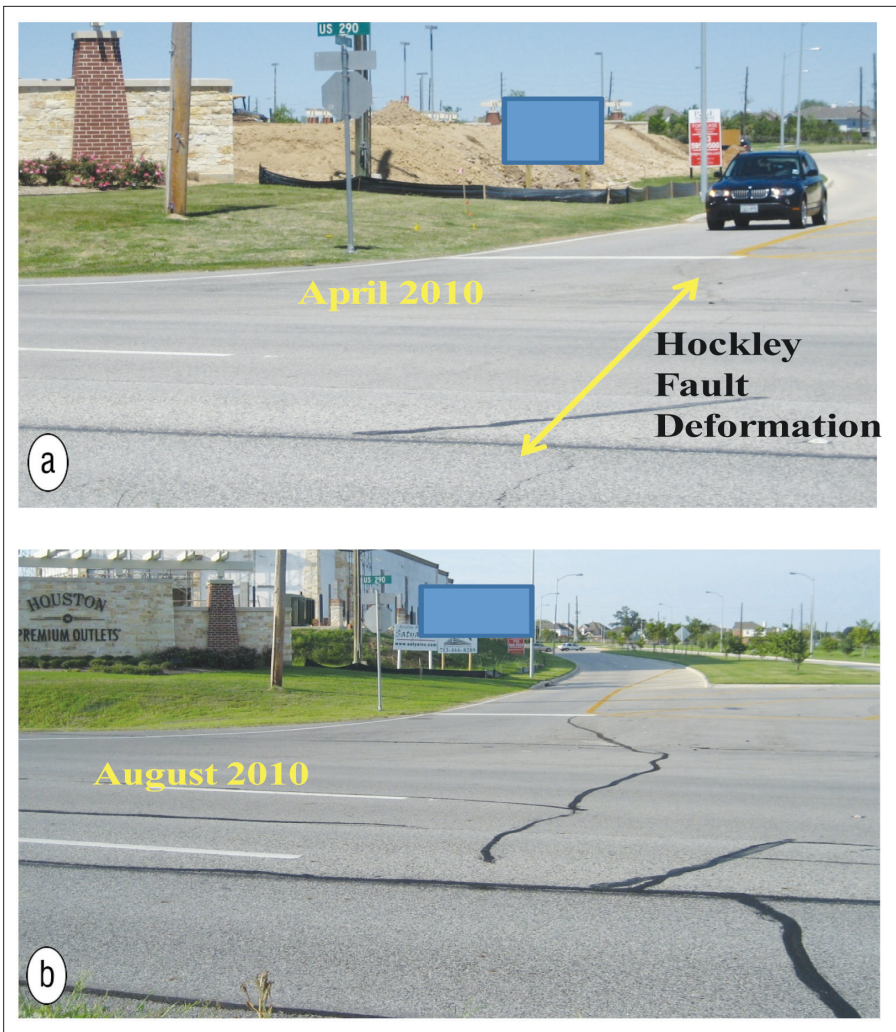
**Figure 13.** Recent pictures of Hockley fault at Highway 290 Frontage and Fairfield Falls Way roads: (a) taken in April 2010 and (b) taken in August 2010. Note the development of the tiny cracks in (a) into significant ones in (b).

Since the measurements discussed previously were taken, a shopping mall was built in the vicinity of the Hockley Fault zone (Figure 12), and Highway 290 was rebuilt and extended, covering the evidence for the fault. Site visits during April and August 2010 provide additional evidence in developing a fault growth past and predictions for the future (Figure 13). Small cracks in the pavement over the main fault trace photographed in April 2010 had extended and widened significantly by August. Note that the cracks in Figure 2b have been filled with asphalt.

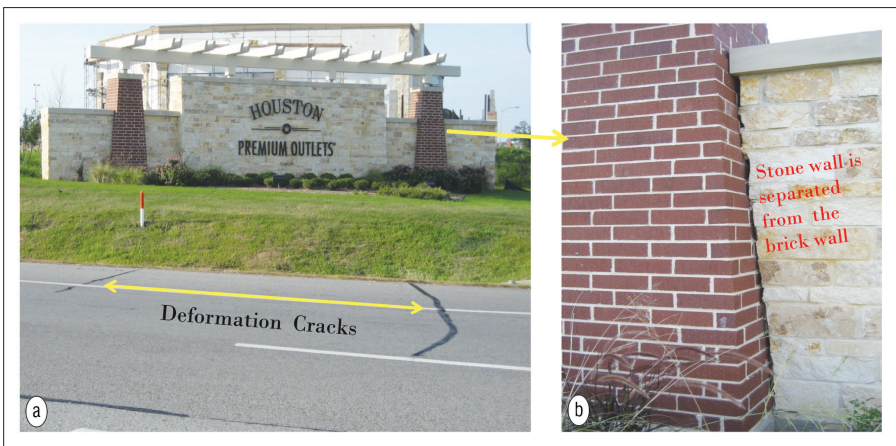
**Figure 14.** Pictures of road (a) and wall deformation (b) to the immediate west of the Hockley fault was taken in August 2010.

Geophysical results previously discussed suggested correlations between several small faults and the cracks observed on Highway 290 frontage roads. Figure 14 shows two developing cracks to the west of the main Hockley fault plane. Mortar stone and brick walls in the background show evidence of unique fault deformation in Figure 14b. The brick wall appears to be separated from the stone wall due to combination of horizontal and vertical offsets expected from this type of growth fault (Figure 1). The original cement holding the brick and stone walls is no longer visible at this location due to the detachment. Although this type of deformation could also be due to local settling or erosion of fill materials beneath the brick wall, its apparent relationship to the cracks in the asphalt are strong evidence for this being fault related.

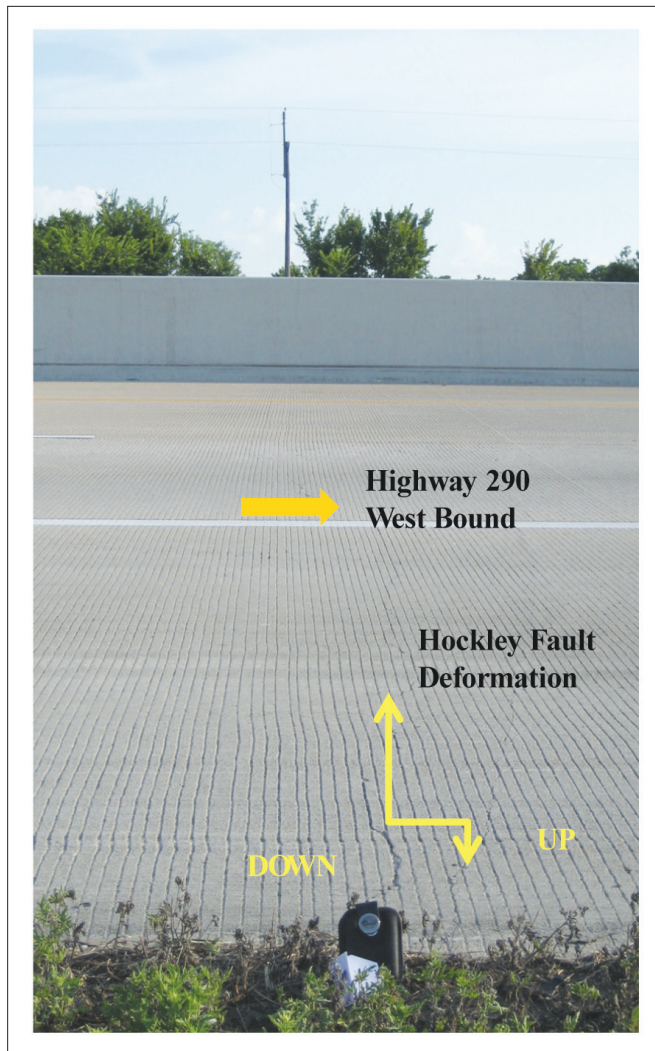
The Hockley Fault continues across Highway 290 (Figure 15) and the uneven highway surface caused by movement of the fault can be felt by an alert driver. This observation is consistent with the geophysical study and is strong evidence that the ground surface in the area is changing with active faulting being one of the drivers. The USGS has published many articles on

**Figure 15.** A recent picture (August 2010) showing revived cracks (main Hockley fault) on the westbound side of Highway 290. The fault deforms the newly built Highway 290 and the feeder roads. The picture was taken facing south.
