Geophysical Signature of Haby Crossing Fault and Its Implication on Edwards Recharge Zone, Medina County, Texas

Mustafa Saribudak*, Alf Hawkins*, Kerlon Saraiva*, Jenna Terez**, Kim Stoker**

*Environmental Geophysics Associates, 9211 Colony Pond Drive, Spring, TX 77379

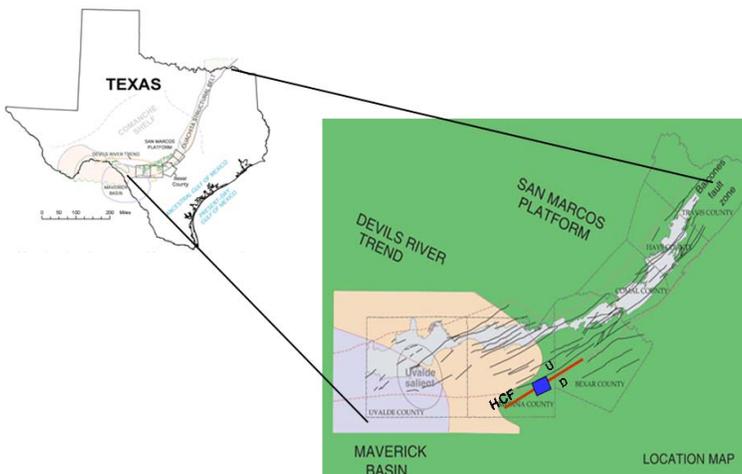
FIGURE 1

Figure 1. Location of Haby Crossing fault and study area. HCF denotes Haby Crossing fault; the blue box indicates the study area.

Resistivity imaging, natural potential (NP), ground conductivity and magnetic surveys were conducted across the Haby Crossing fault, which is located in eastern Medina County of San Antonio (Figure 1). The study area is within the Balcones Fault Zone and is limited between CPS Energy's new proposed transmission line of pole locations 80 and 82 (Figure 2).

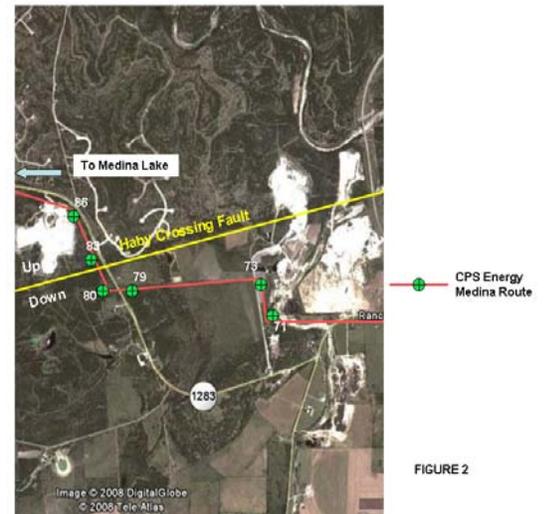
FIGURE 2

Figure 2. Site map showing partial location of Medina-CPS Transmission Line.

currently constructing (Figure 2). We should mention that we performed geophysical surveys, prior to this work, along the transmission line to determine locations and depth of voids beneath the proposed pole locations. In this way, pole locations can be relocated if necessary to reduce the potential for the construction to impact threatened or endangered species and to locate more competent limestone to seat the pole footings.

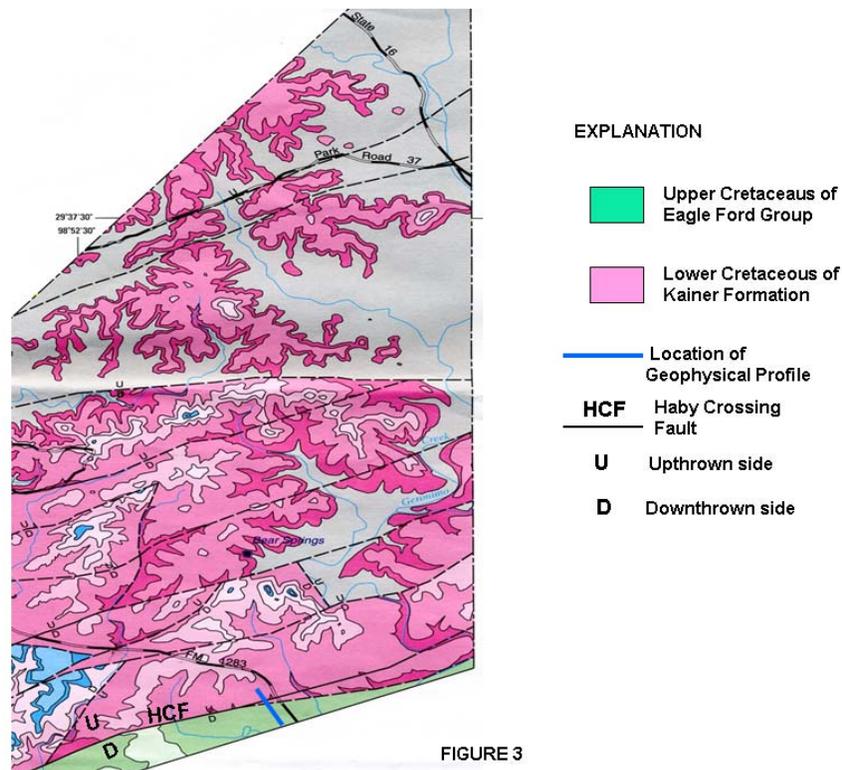
FIGURE 3

A detailed geological study by Small and Clark, 2000 shows that the study area for the geophysical work includes the geological units of Eagle Ford Group of Upper Cretaceous and Dolomitic Member of Kainer Formation of Lower Cretaceous (Figure 3). The Lower Cretaceous unit of Kainer Formation of the Edwards Group is known to be karstified, faulted limestone (Stein and Ozuna, 1996).

Figure 3. Geological map of the study area. The geological map is taken and modified from Small and Clark, 2000.

The Haby Crossing fault, which is located within the proposed route of the CPS Energy power line, has more than 300+ feet displacement along its entire length (Small and Clark, 2000). As a result, the Trinity Aquifer is juxtaposed with the Edwards Aquifer along the fault. The location of geophysical profile is shown in Figure 3. Two field pictures of the study area are shown in Figures 4 and 5.

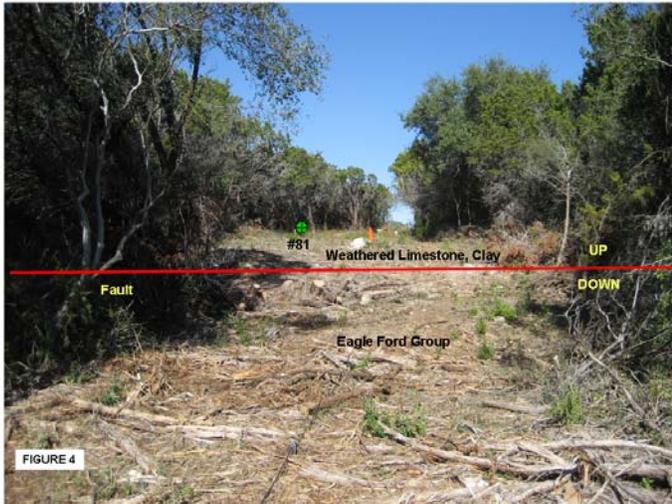
Figure 4. Photograph of a fault within Eagle Ford Group. View is to the north. The location of this fault is approximately mapped by Small and Clark, 2000.

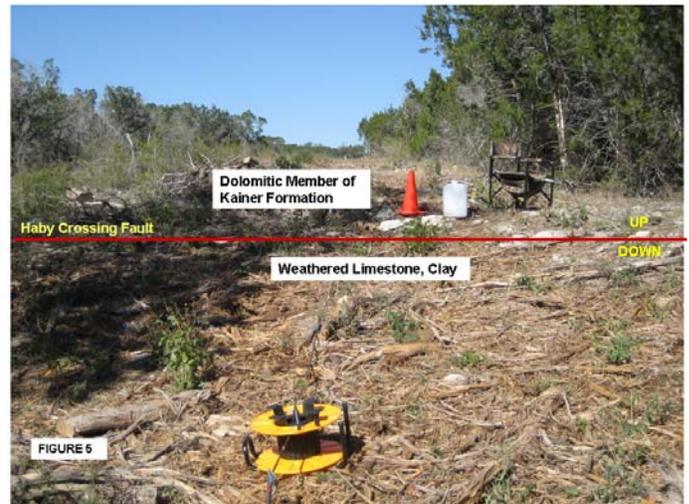
Figure 5. Photograph of the Haby Crossing fault. View is to the north.

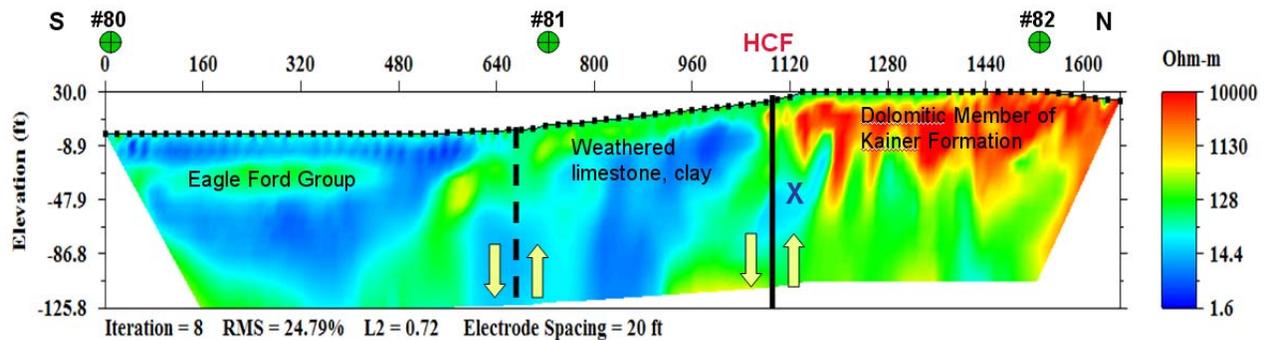
FIGURE 6

Figure 6 shows the resistivity imaging data taken across the Haby Crossing Fault. Based on the geological information provided by Small and Clark, (2000), we identified the geological units present in the field and labeled them on the resistivity data.

The resistivity values of geological units along the profile vary between 2 and 10,000 Ohm-m. The depth of exploration of resistivity data varies between 100 and 125 feet. The resistivity data indicates two faults locations at 680 and 1080 feet, respectively. Location of the first fault along the resistivity profile corresponds to where the Eagle Ford Group rocks are present. The resistivity values of these rocks vary from 2 to 150 Ohm-m, which corresponds to clay and weathered limestone. The second fault, which is the Haby Crossing fault, juxtaposes the Eagle Ford Group with the Dolomitic member of Kainer Formation. The Dolomitic Member appears to consist of two types of limestone as far as their resistivity values are concerned:

- 1) Resistivity values with 500 to 10,000 Ohm-m, which are displayed with yellow and red colors on the resistivity imaging profile;
- 2) resistivity values with 50 to 500 Ohm-m, which are shown with the green color.

It should be noted that the contact surface between the high and low resistivity limestone layers of Kainer Formation have a very irregular geometry, which may be caused by the tectonic and/or weathering activity.

There is a very low-resistivity anomaly (i.e., 2 to 10 Ohm.m) to the north of the Haby Crossing fault breaching into the higher resistivity limestone layers. This low-resistivity anomaly, which is shown with a letter "X," may be caused by a clay-filled void or cave.

Figure 6. Resistivity imaging profile across the Haby Crossing fault. HCF denotes Haby Crossing fault. Dashed vertical line corresponds to a known fault determined by Small and Clark, 2000.

Resistivity, ground conductivity, magnetics and natural potential surveys identified significant anomalies across the Haby Crossing fault. The resistivity data show the location of Haby Crossing fault which juxtaposes the Eagle Ford Group of Upper Cretaceous with the Dolomitic Member of Kainer Formation of Lower Cretaceous. There is another apparent fault identified by the resistivity survey within the Eagle Ford Group. Low-resistivity materials appear to breach into higher-resistivity materials, which may be indicative of presence of the voids, conduits, or caves. The geometry of the stratigraphic horizons between the faults and neighboring areas is quite irregular due to the tectonic and weathering activity.

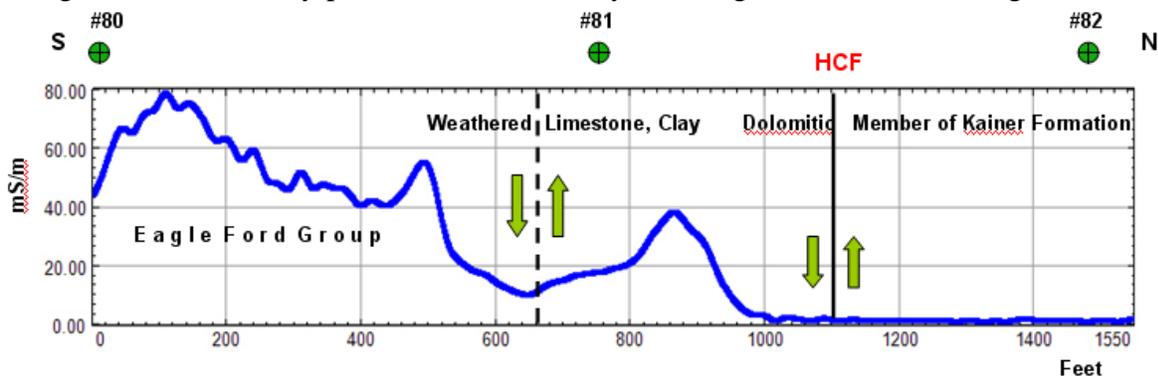
FIGURE 7

A ground conductivity profile across the Haby Crossing fault is shown in Figure 7. There are

conductivity highs (up to 80 mS/m) and lows (down to 15 mS/m) between stations 0 and 1000 feet, which correspond to locations of the Eagle Ford Group and weathered and fractured limestone and clay and/or shale. The conductivity values are near to zero between the stations

1000 and 1550 feet. This conductivity low is caused by the resistive Dolomitic Member of the Kainer Formation.

Figure 7. Conductivity data across the Haby Crossing fault.

The conductivity data show the location of the Haby Crossing fault quite distinctly. The conductivity values of 40 mS/m drop down to almost 0 mS/m over the fault. There are significant conductivity variations from 80 to 40 mS/m across the Eagle Ford Group. This variation is probably related to changes in the water content of the clay and mineral chemistry of the rocks. However, the conductivity values drop to 20 mS/m between stations 500 and 800 feet. This is probably caused by the presence of weathered limestones in the near-surface. In fact, we did observe some limestone outcrops in that area.

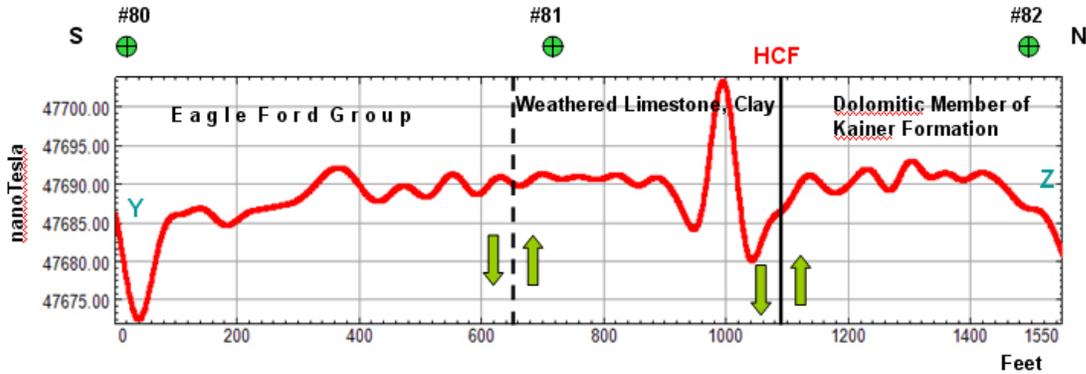
FIGURE 8

A magnetic profile across the Haby Crossing fault is given in Figure 8. There are two significant magnetic anomalies along the profile. The first anomaly is between stations 900 and 1150 feet, which approximately corresponds to the area between the two faults where weathered limestone and clay-filled limestone are present.

The source for the magnetic anomaly could be due to the susceptibility contrast between the Eagle Ford Group and Dolomitic Member of Kainer Formation and/or localized ferrous mineralization along the fault plane. There are two additional anomalies along the profile which are located at the beginning and end of the profile, respectively; and are shown with letters “Y” and “Z.” Sources of these anomalies are probably due to faults. In fact, the Small and Clark, (2000) study indicates a fault at the approximate location of where the Y anomaly is present.

Figure 8. Magnetic data across the Haby Crossing fault.

The magnetic data show the location of the Haby Crossing fault with a quite distinct high anomaly. This anomaly is probably caused by the presence of ferrous mineralization and/or karstic features, such as caves containing ferrous materials, along the fault zone. There are two other similar anomalies at the beginning and end of the magnetic profile. There is no additional magnetic information on these anomalies to speculate on their origin.

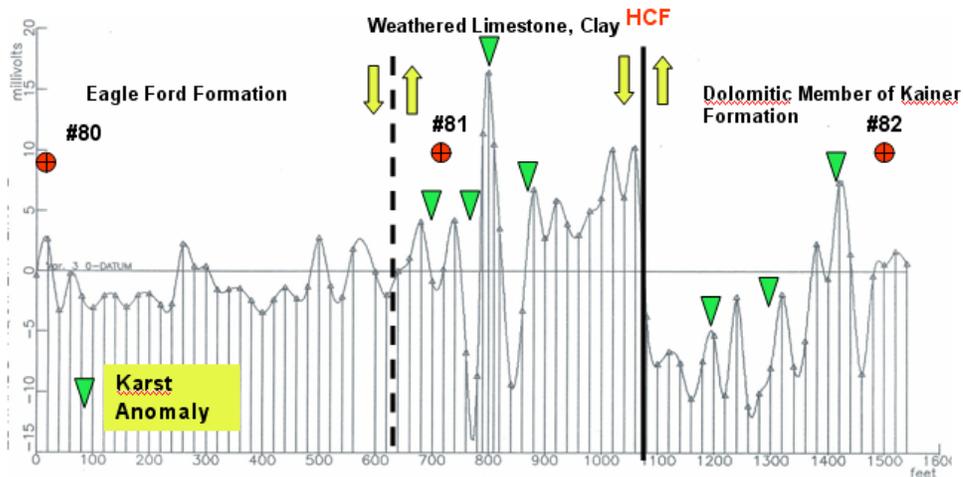
FIGURE 9

NP data across the Haby Crossing fault are given in Figure 9. The NP data indicate significant karst anomalies (voids, conduits, caves, etc.) within the faults and neighboring areas

along the profile. The NP anomaly across the Haby Crossing fault is quite distinct where NP values fall from 20 to -5 mV. There is no significant karst anomaly observed within the Eagle Ford Group.

Figure 9. Natural potential data across the Haby Crossing fault.

The NP data indicate significant karst anomalies (voids, conduits, caves, etc.) within the faults and neighboring areas along the profile. The NP anomaly across the Haby Crossing fault is quite distinct where NP values fall from 20 to -5 mV. There is no significant karst anomaly observed within the Eagle Ford Group.
