Urban Geophysics: Geophysical Signature of Mount Bonnell Fault and Its Karstic Features in Austin, TX

by *Mustafa Saribudak*, Environmental Geophysics Associates, Austin, TX

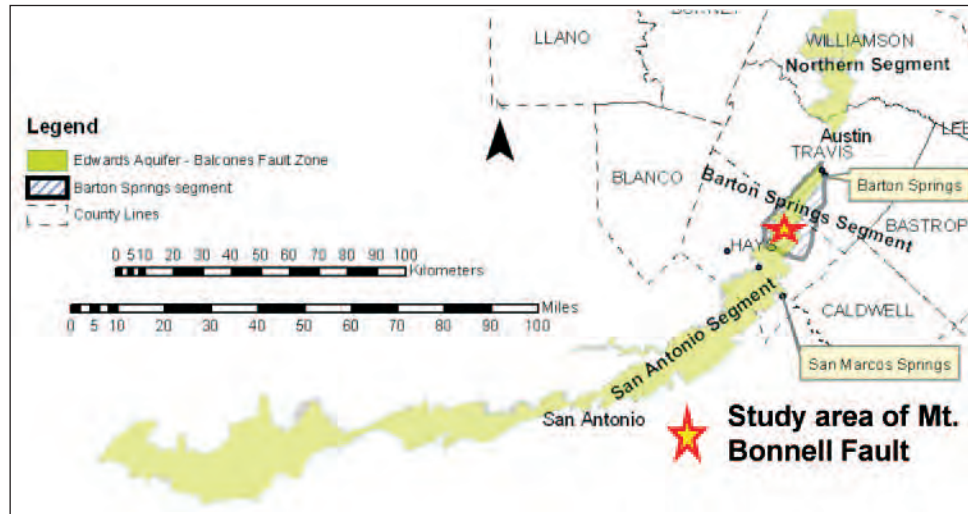
Figure 1: Balcones Fault Zone Portion of the Edwards Aquifer in Central Texas (Hauwert, 2009).

faults have positioned the geologic units into a framework that juxtapose contrasting rock, soil, and terrain, thereby establishing a major physiographic boundary, the Balcones Escarpment, which extends through west Austin, separates the Edwards Plateau to the west from the Blackland Prairies of the Gulf Coastal Plain to the east (Collins and Woodruff, 2001). The Balcones escarpment, with a topographic relief as great as 300 feet in Austin, is a fault-line scarp, and consists of normal faults, which dip toward the east and southeast. The BFZ's most prominent fault is the Mount Bonnell fault, which comprises the northernmost part of the fault zone with a throw of near 600 feet. The Lower Cretaceous Glen Rose Formation is at the surface to the west of the MBF, while east of the fault zone younger rocks of Edwards Aquifer are at the surface (Figure 1).

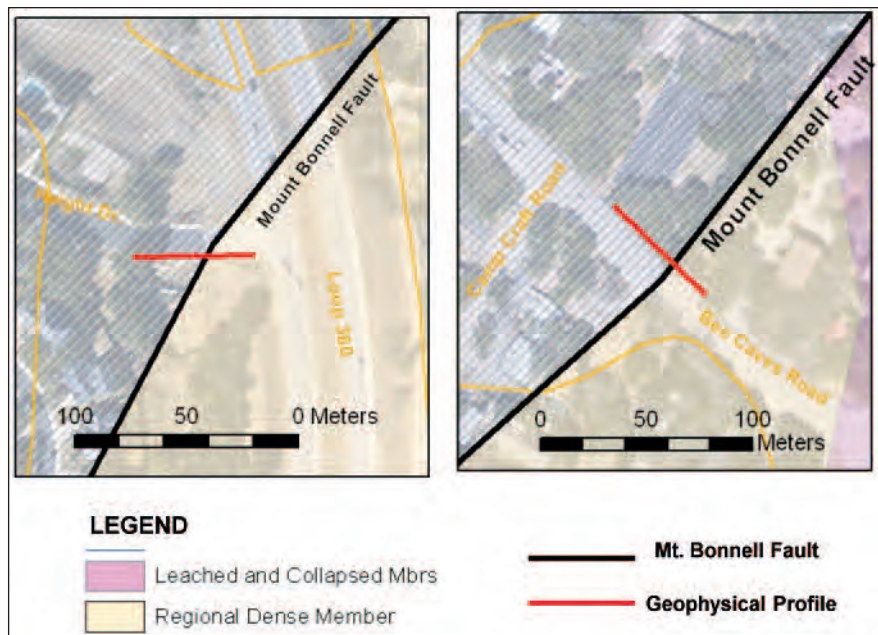
Figure 2: Surface geology of geophysical survey sites. Geologic interpretation modified from Hauwert, 2009 and Rodda et al. (1970) by Nico Hauwert.

In this study, however, I demonstrate the utility of integrated surveys for the near-surface characterization of the MBF in the Austin area (Figure 2). To my knowledge, this is the first application of integrated geophysical techniques to the characterization of karstic features in the metropolitan Austin area. The geophysical surveys were performed at the intersections of Height Drive and Highway 360, and Bee Cave Road and Camp Craft Road (Figure 2). Conductivity, magnetic, GPR and NP methods were chosen for their ability to very rapidly map variations in their respective physical attributes such as conductivity, magnetic susceptibility, dielectric contrast and ambient electrical current within the surface. 2D resistivity imaging surveys were conducted to provide information about variation in electrical resistivity as a function of depth. Results of these surveys are described in the following section.

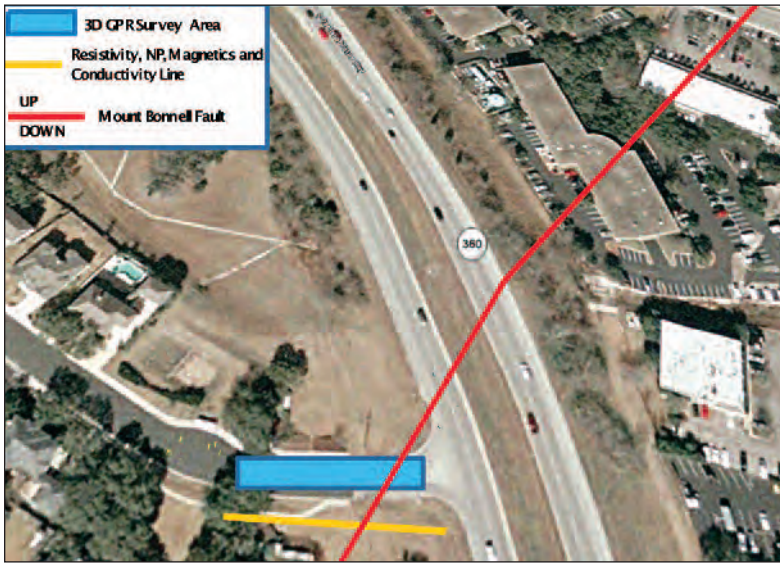
Figure 3: Site map showing the location of geophysical profiles and the Mount Bonnell fault. The fault location is taken from Hauwert, 2009.

A site map of the study area including the location of geophysical profiles and the MBF is shown in Figure

Sixteen GPR profiles were collected along Height Drive perpendicular to the Mt. Bonnell fault (see **Figure 3**), and were used to create 3-D GPR amplitude depth slices. (see **Figure 6**). The trend of the fault is well exposed at depth slices of 2-3 ft, and 3-4 feet.

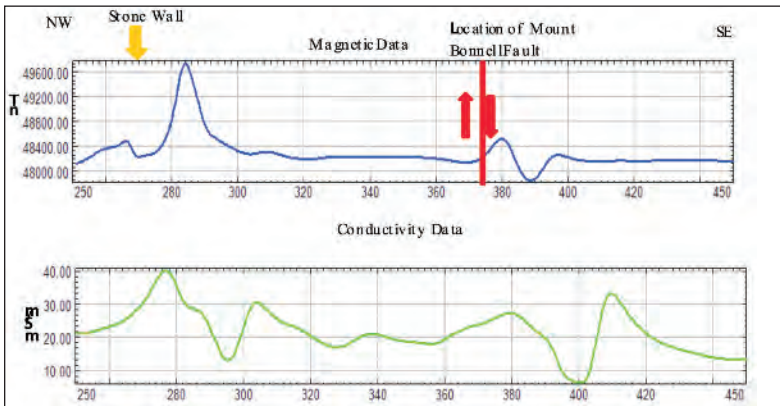
Figure 4: Magnetic and conductivity data across the Mount Bonnell fault. A magnetic high, conductivity high and low anomalies are observed between the stations 270 and 300 feet. Another anomaly on both profiles, caused by a buried pipe, is shown between the stations at 370 and 410 feet. The location of Mount Bonnell is referenced based on the geological data (Hauwert, 2009).

3. The magnetic and conductivity data are shown in **Figure 4**. The magnetic data indicate a high anomaly between the stations at 270 and 290 feet, whereas the conductivity data shows a high and low between the stations at 270 and 310 feet. Sources for these anomalies are due to changes in the magnetic and conductivity properties of the Glen Rose Formation. Both data sets also indicate a pipe anomaly between stations 380 and 410 feet. This anomaly is due to a known utility pipe, which is observed at the site.

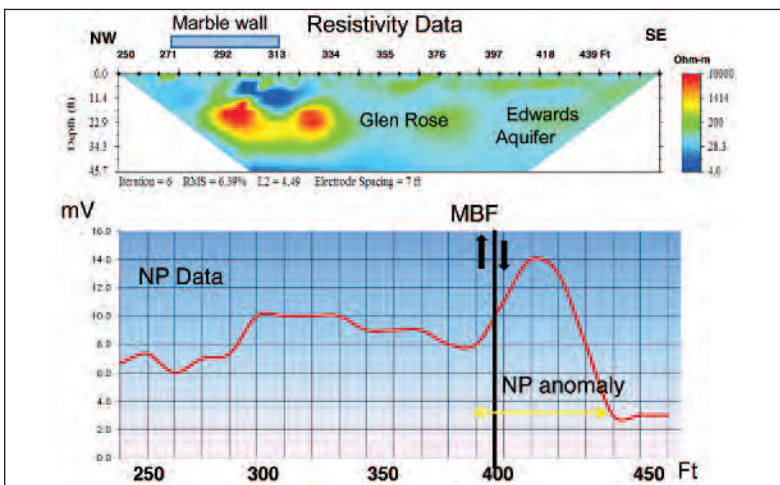
Figure 5: Resistivity imaging (above) and NP (below) data across the Mount Bonnell fault. The resistivity data does not indicate the fault. The location of the fault is based on the geological data (Hauwert, 2009). However, the NP anomaly indicates the fault about 25 feet further SE than its geologically known location.

Figure 5 shows the resistivity imaging and NP data along the same profile as of **Figure 4**. The resistivity data indicates a very significant anomaly consisting of high and low resistivity anomalies between stations 280 and 320 feet. The resistivity profile does not indicate any fault anomaly where it crosses the MBF, however, the NP data shows a typical fault anomaly (sine wave) across the known fault location.

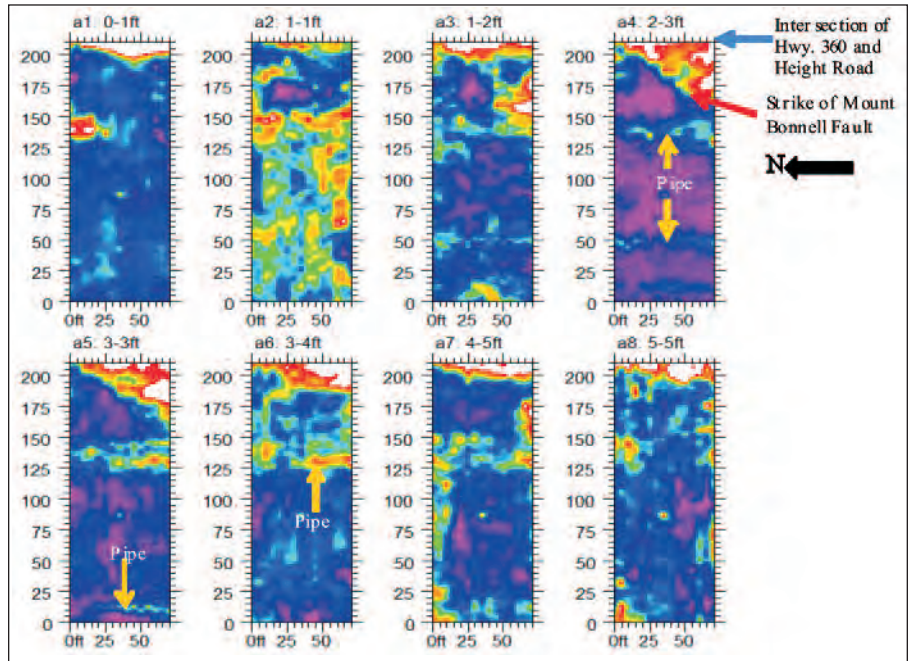
Figure 6: 3-D GPR depth slices showing the strike of Mount Bonnell fault and subsurface pipes. Red color shows the highest amplitude whereas the blue lowest.

In summary, NP and the GPR data indicate the location of the MBF, which is consistent with the geological data (Hauwert, 2009). The resistivity, magnetic and conductivity data show cave-like anomalies. GPR, magnetic and conductivity data show location of subsurface pipes across the study area. Findings of geophysical surveys are given in **Table 1**. There is a patched asphalt area on Height Drive where the fault crosses, and the repair on the site may have been necessary because of the near-surface deformation due to the karstic features.

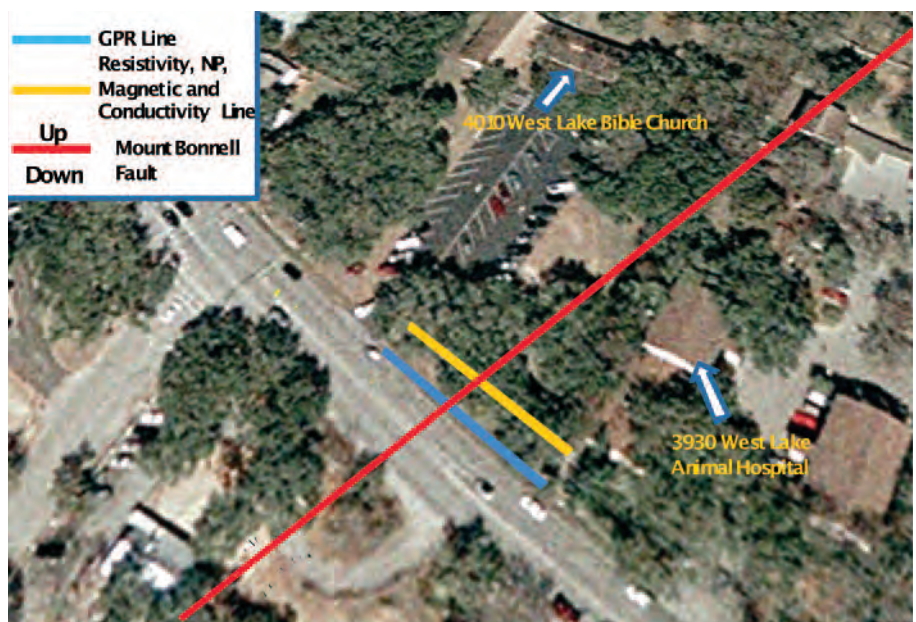
Figure 7: Site map showing locations of geophysical profiles and the MBF.

MBF are shown in Figure 7. Geophysical surveys, except the GPR, were all conducted along the grassy area between the two driveways of the West Lake Bible Church and West Lake Animal Hospital. The GPR data was collected along Bee Cave Road adjacent to other profiles. There is an observed incipient sinkhole in the study area.

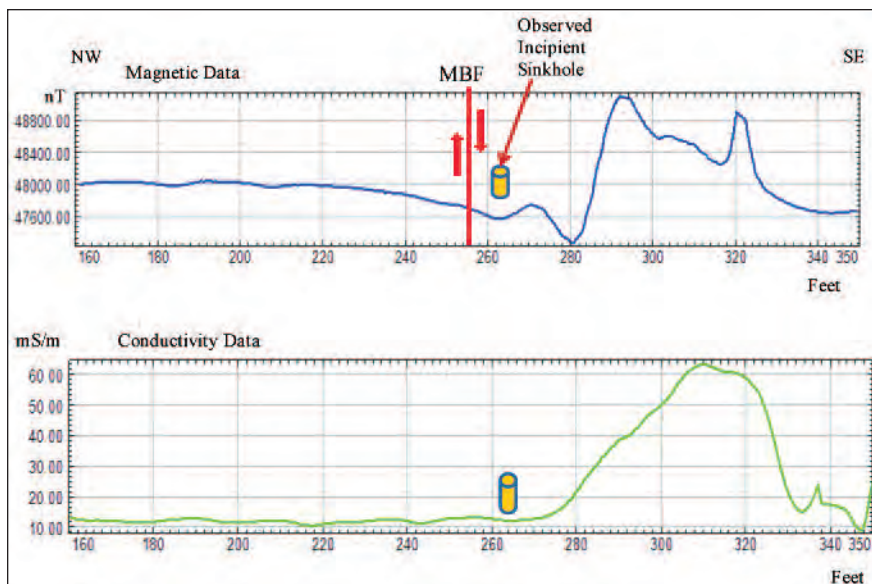
Figure 8: Magnetic and conductivity profile across the MBF. There is a ferrous electrical pole near the station at 250 feet, but observed high magnetic and conductivity anomalies between the stations at 260 and 330 appear to be caused by subsurface sources. MBF stands for Mt. Bonnell Fault and it is location determined by geological field observation (Hauwert, N., Pers. Comm., 2010).

The magnetic and conductivity data are given in Figure 9 and they show high magnetic and conductivity anomalies between the stations 279 and 330 feet. The source of these anomalies appears to be subsurface. The incipient sinkhole is located at the station at 265 feet. The resistivity and NP data are given in Figure 9. The resistivity data show karstic anomalies, cave, sinkhole, collapsed materials, etc., along the entire length. The high magnetic and conductivity anomalies correlate well with the locations low resistivity material (≤ 20 ohm-m). Based on this correlation, the source of the magnetic and conductivity anomalies can be attributed to magnetic soils in the subsurface. The NP data shows an unique “U” type anomaly along the profile. The NP values range between 10 and -38 mV. The NP anomaly appears to be caused by a combination of the fault and a sinkhole. A GPR profile from the site is shown in Figure 10, which indicates a sinkhole anomaly between stations 242 and 252 feet.

In summary, (see also Table 2) the magnetic and conductivity data show high amplitude anomalies on the downthrown side of the Mt. Bonnell fault. Low resistivity anomalies are also observed across the magnetic and conductivity anomalies. Sources for these anomalies could be collapsed clayey and silty soils. The NP data displays high values on the upthrown side of the fault. There is a significant low NP anomaly where the incipient sinkhole is observed. Overall, the NP anomaly is interpreted to be the combination of the fault and the sinkhole feature.

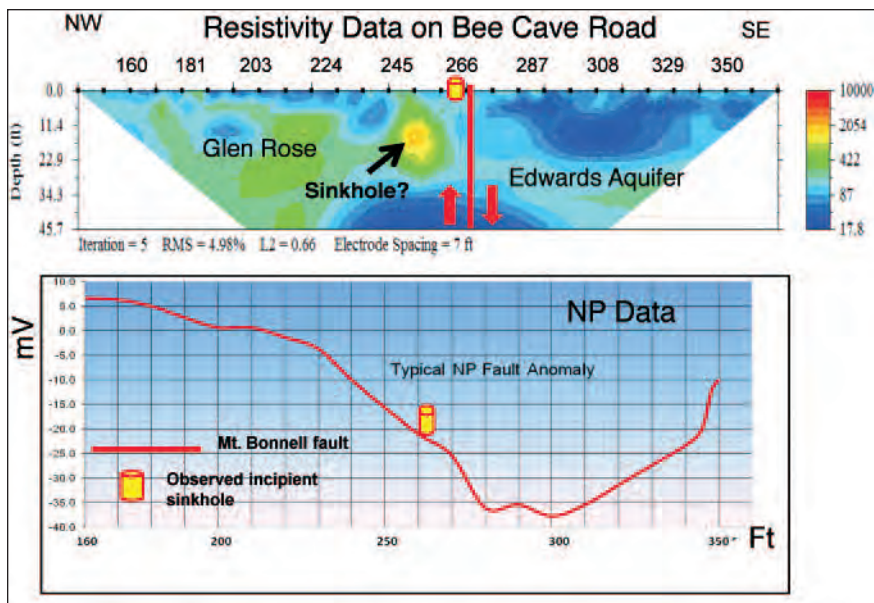
Figure 9. Resistivity and NP data across the Mount Bonnell fault along Bee Cave Road. Location of the fault is placed in the field by examination of the outcrops on the either side of the fault (Nico Hauwert, pers. comm., 2010). Note that the NP data indicates a fault anomaly i.e. sinusoidal curve and a negative anomaly which may be due to a significant sinkhole in the subsurface. Also note the orange circular high resistivity anomaly between stations 245 and 260 feet, which could be due to a sinkhole.

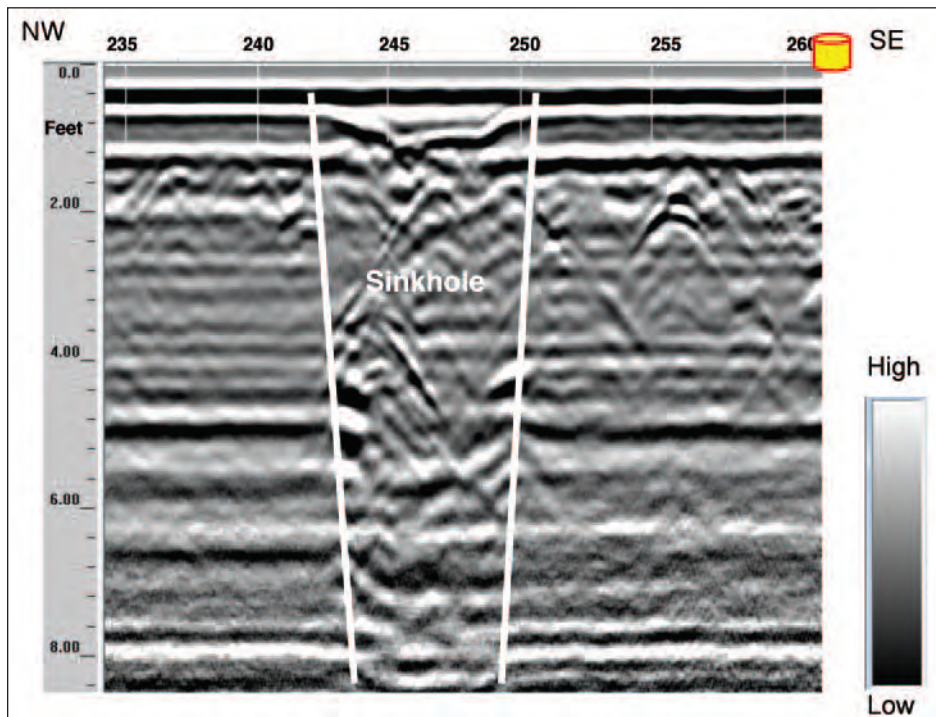
Figure 10. A section of GPR data across the Mt. Bonnell fault. A sinkhole anomaly is located between stations 242 and 252 feet. Note that the sinkhole is very close to the surface at the Bee Cave Road. Location of this sinkhole correlates well with the incipient sinkhole and the orange circular high resistivity anomaly that are observed on the surface and the resistivity data, respectively.
