Integrated geophysical studies over an active growth fault in Houston

MUSTAFA SARIBUDAK, *Environmental Geophysics Associates, Houston, USA*
BOB VAN NIEUWENHUISE, *Earth-Wave Geosciences, Houston, USA*

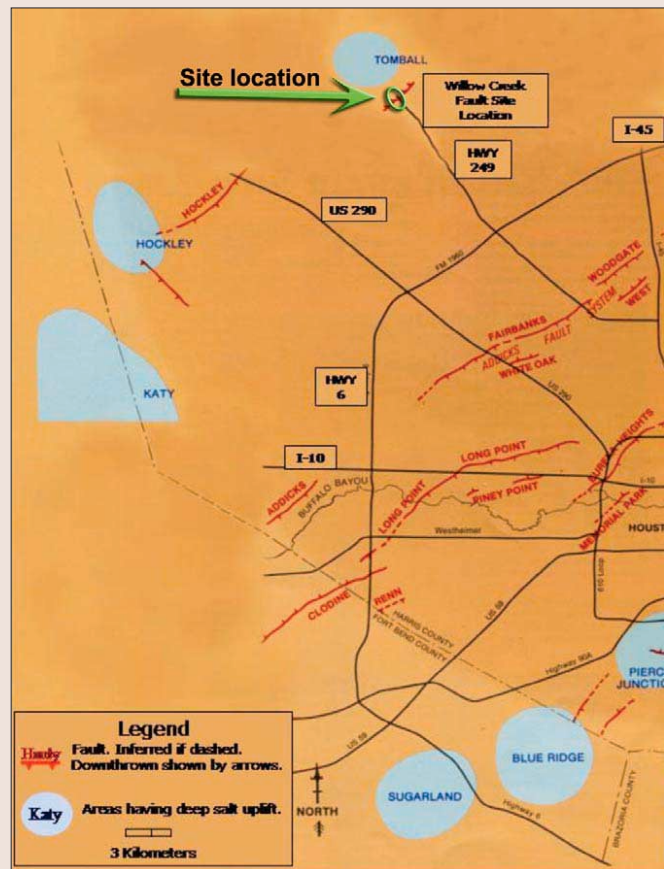
Figure 1. Willow Creek fault site location, annotated as a green ellipse (after Elsbury et al.).

This paper presents and evaluates the use of four noninvasive geophysical methods for investigating the Willow Creek growth fault along Highway 249 in northwest Houston (Figure 1).

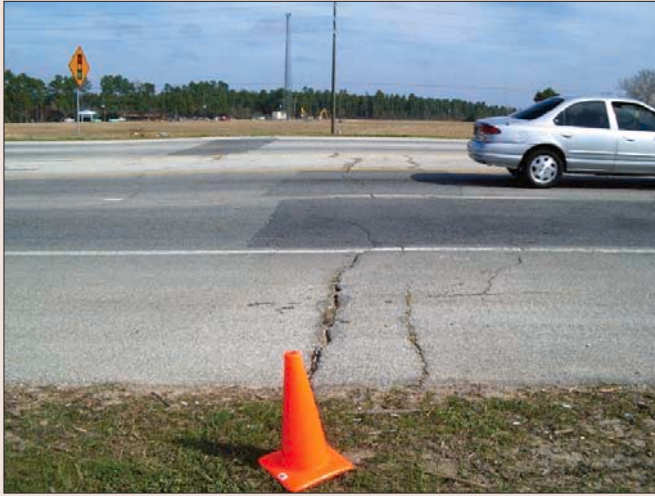
Figure 3. Willow Creek fault scarp across Highway 249. Note the several fractures and asphalt patches on the road. The picture was taken facing east. The car was going toward the bridge on the south (upthrown) side of the fault.

north of the Willow Creek Bridge, trends in the NE-SW direction, and dips to the north (Figure 2). This fault is an antithetic listric fault related to the south-dipping regional Tomball synthetic listric fault about 3 km north. A discrete pavement break crossing both south and north bounds of Highway 249 clearly marks the presence of the fault (Figure 3).

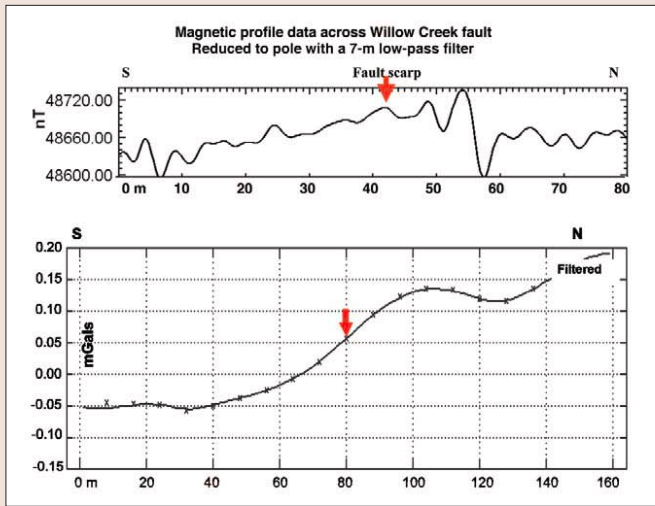
Figure 7. Correlation of (top) magnetic and (bottom) gravity data across Willow Creek fault. Note the gravity high on the downthrown side. The regional gravity field is not removed.

Microgravity and magnetic data (Figure 7) were acquired along resistivity line 2 (L2 in Figure 2). The simple Bouguer gravity data are referenced to the IGF1967 and the GRS1967. The data were terrain- and elevation-corrected using elevation from a Berger/CST auto-level tied to local reference/bench marks. A Bouguer correction density of 2.2 gm/cc was utilized for the shallow, unconsolidated sediments. Microgravity data were filtered using a 7-m low-pass filter. Data can be interpreted to indicate a gravity high correlated with the downthrown side of the fault. The magnetic data, reduced to pole and filtered using a 7-m low-pass filter, show a magnetic low on the downthrown side of the fault.

The fault locations interpreted from the magnetic and gravity data correlate extremely well with the location of the pavement break (fault scarp) observed on the ground.

Gravity data across the fault have been modeled and interpreted using the analog equation for a thin fault, the thin-slab equation, and Talwani-type 2D modeling. The

results obtained from the thin-slab equation and analog equation for a thin-fault indicate the vertical throw for the shallow fault at Willow Creek could possibly be as small as 3 m while the main fault appears to have a vertical throw of approximately 17 m. The full vertical throw of the fault is not detectable on the microgravity data whereas it appears detectable in the regional data (Figure 8). This difference is due to the scale of the feature detected by the microgravity versus the feature detected by the regional gravity. A regional gravity field was not removed from the microgravity as we are attempting to detect an extremely low-amplitude (<0.25 mGal) effect at the site.

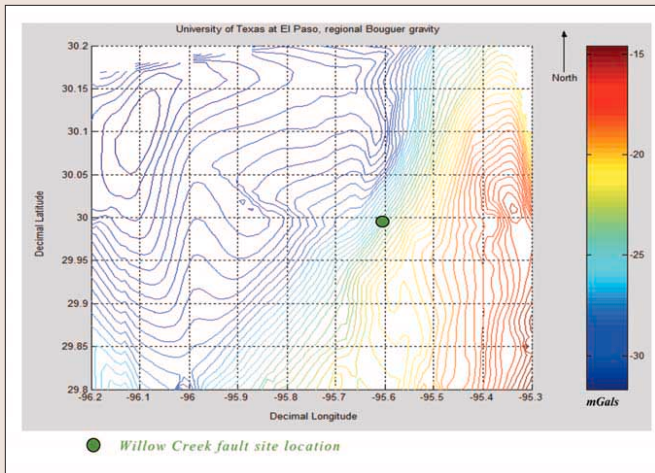
Figure 8. Map showing University of Texas El Paso regional complete Bouguer gravity in NW Houston. Note the steep gravity gradient at the location of the Willow Creek fault site. The Willow Creek fault is visible on the surface at the location marked (Figure 3).
