2D Resistivity Imaging Investigation of Long Point, Katy-Hockley, Tomball and Pearland Faults, Houston, Texas

Mustafa Saribudak

Environmental Geophysics Associates, Austin, TX, USA
ega@pdq.net

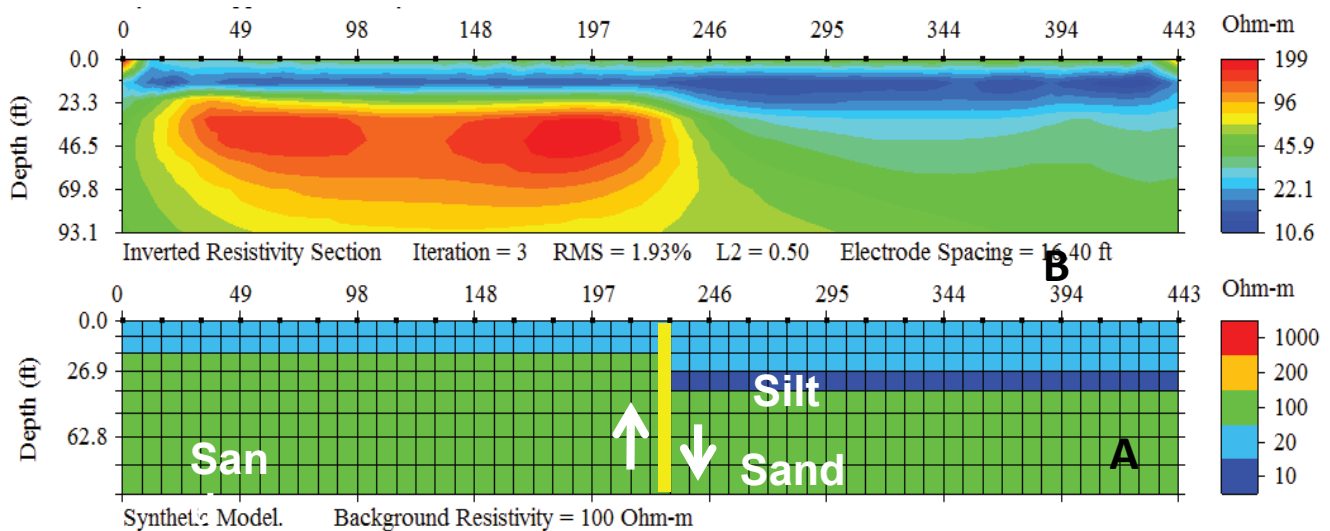
Figure 6. Sections showing (A) a synthetic fault model, and (B) resistivity inversion result of fault model within sand and clayey soils.

in the soil properties mentioned above. In general, in the absence of tectonic activity, the soil layers should present horizontal layers in the Gulf Coast region. In the case of a growth fault, the different soil layers are juxtaposed within the fault zone. We attempted to model such a growth fault. Figure 6A indicates the synthetic model showing the silt, sand and clay layers displaced along the fault with a 30 feet vertical offset. Figure 6B and C show the inverted resistivity and synthetic apparent resistivity section, respectively. Figure 6B displays the fault movement and the thickening the soil layers on the downthrown side.

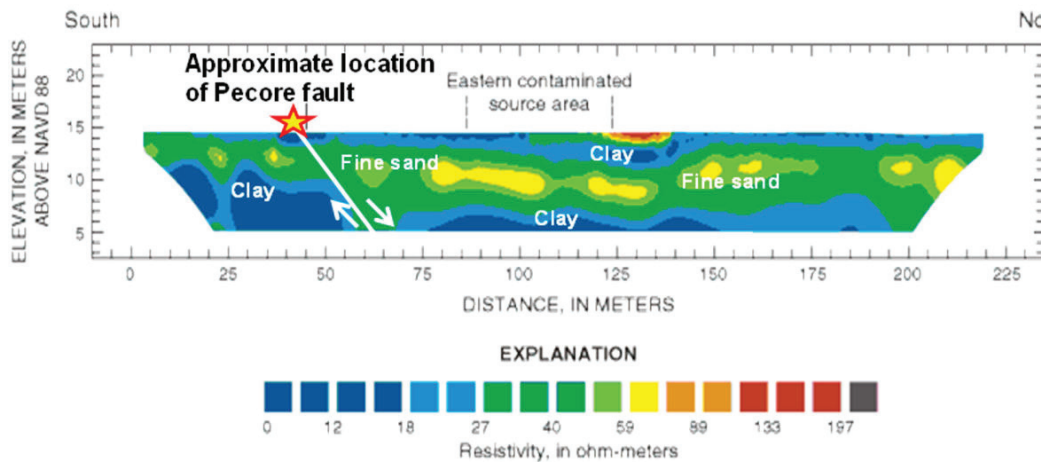
Figure 14. Resistivity profile showing the resistivity data across the Pecore fault (modified from Kress and Teeple, 2005).

Previous resistivity results of by Saribudak and van Nieuwenhuise (2006), and Saribudak (2011) indicated similar anomalies across the Willow Creek and Hockley faults, respectively. In a similar study, Kress and Teeple (2005) obtained resistivity profiles coupled with borehole data across the Pecore fault in Houston (Figure 1). Their results (Figure 14) indicate discontinuous sand pockets and normally-displaced clay layers across the fault.
