# Geophysical mapping of the Hockley growth fault in northwest Houston, USA, and recent surface observations

MUSTAFA SARIBUDAK, *Environmental Geophysics Associates*

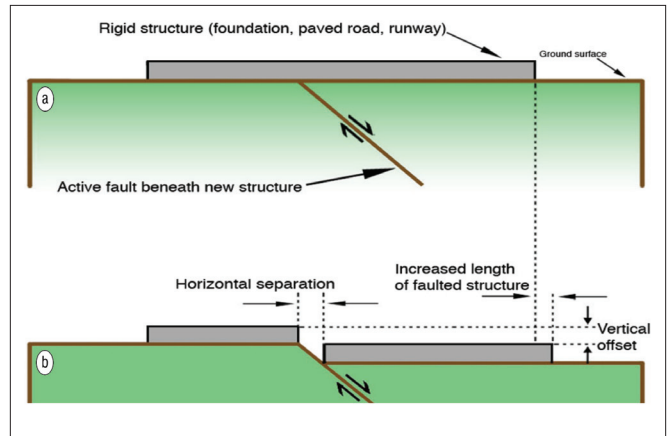
**Figure 1.** Effect of fault movement on a rigid structure built on an active fault. (a) Original construction; (b) structure damaged by fault movement. Both vertical offset and horizontal separation are necessary consequences of displacement. Rigid structures may literally be pulled apart as faulting proceeds (modified from Elsbury et al. 1980).

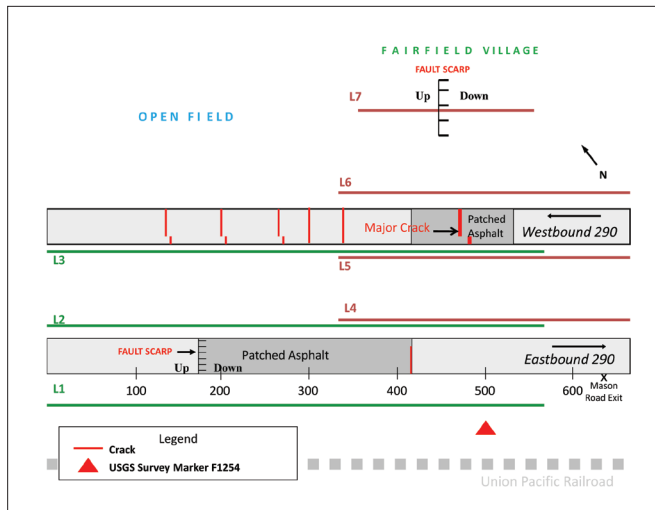
**Figure 3.** Schematic map of Hockley fault at Highway 290 and Fairfield Village. The thinner red lines show fracture locations. Resistivity data were collected along Lines L1, L2, L3, L4, L5, L6, and L7. GPR data were collected only along Line 1 (L1). Not to scale.

During the surveys in 2004, I sketched the locations of the cracks and patched pavement locations on both sides of the highway and mapped a discrete fault scarp on the south side of the highway (Figure 3). Another fault scarp was also mapped along one of the resistivity profiles, in an open field between the highway and Fairfield Village (Figure 3). In addition, a major crack is observed crossing the highway on the north side (Figure 3 and 4). Resistivity profiles L4, L5, and L6 crossed over this significant crack.
